# ***Wollongbar (II) Shipwreck Inspections 2019 Off Crescent Head, NSW***

**By: Dr Brad Duncan**  
**Senior Maritime Archaeologist, Specialist Services Team**  
**Heritage NSW**  
**Department of Premier and Cabinet**

**Report Prepared by Dr Brad Duncan:** August 2020, revised April 2021.

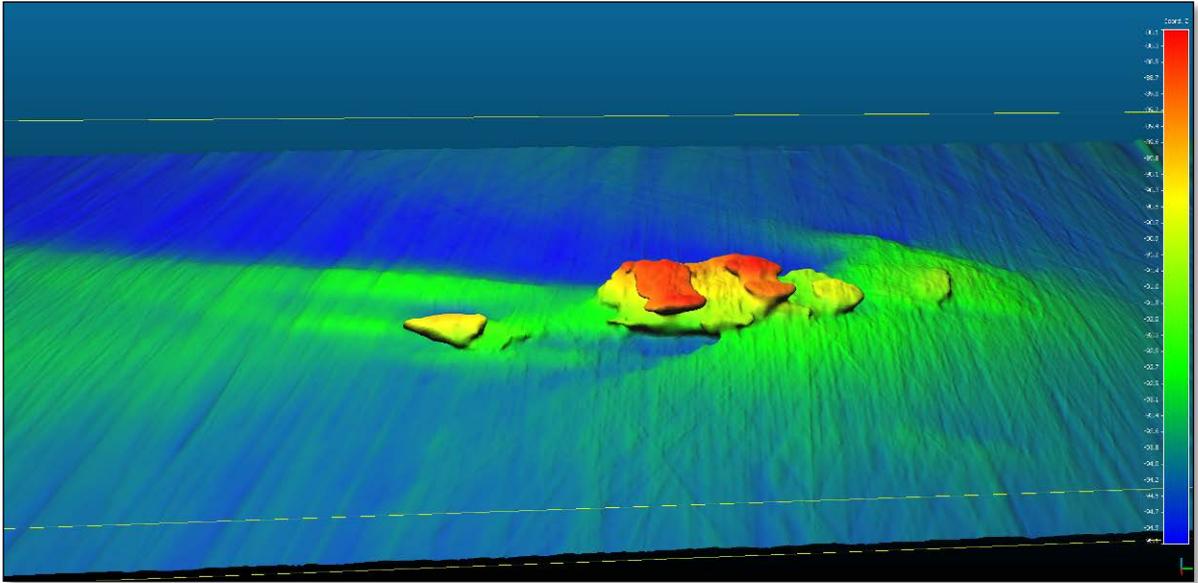
Figure 28: Post processed multibeam data of the wreck site with bow on left and stern on the right (Image: AUS ROV 2019)

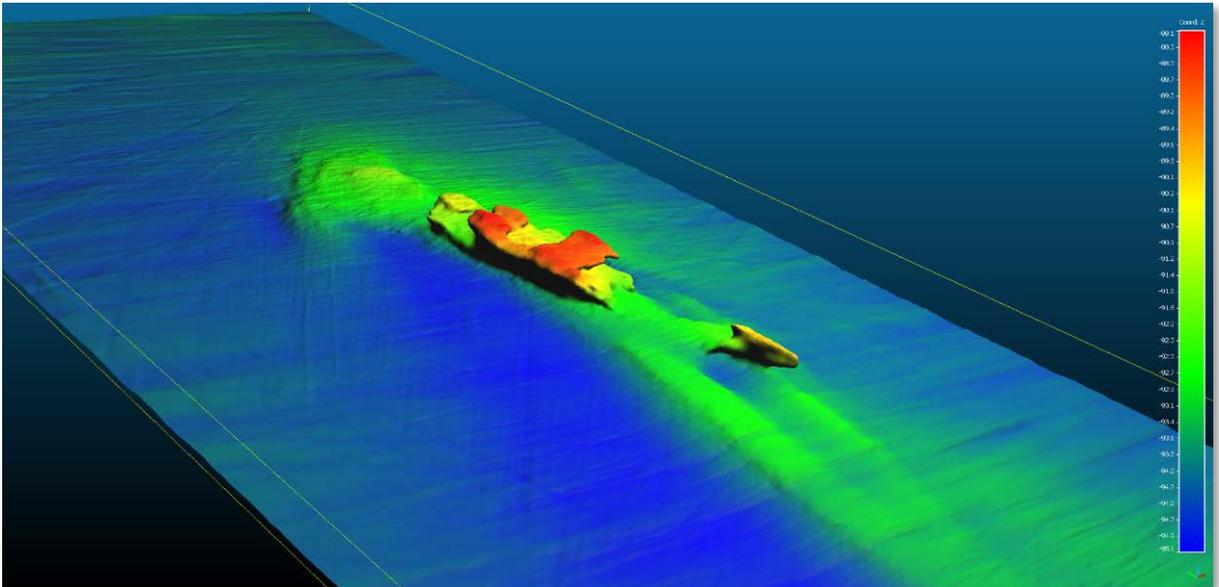
Figure 29: Processed multibeam data of the wreck site showing signs of damage aft of the bow on right and at the stern on left (Image: AUS ROV 2019)

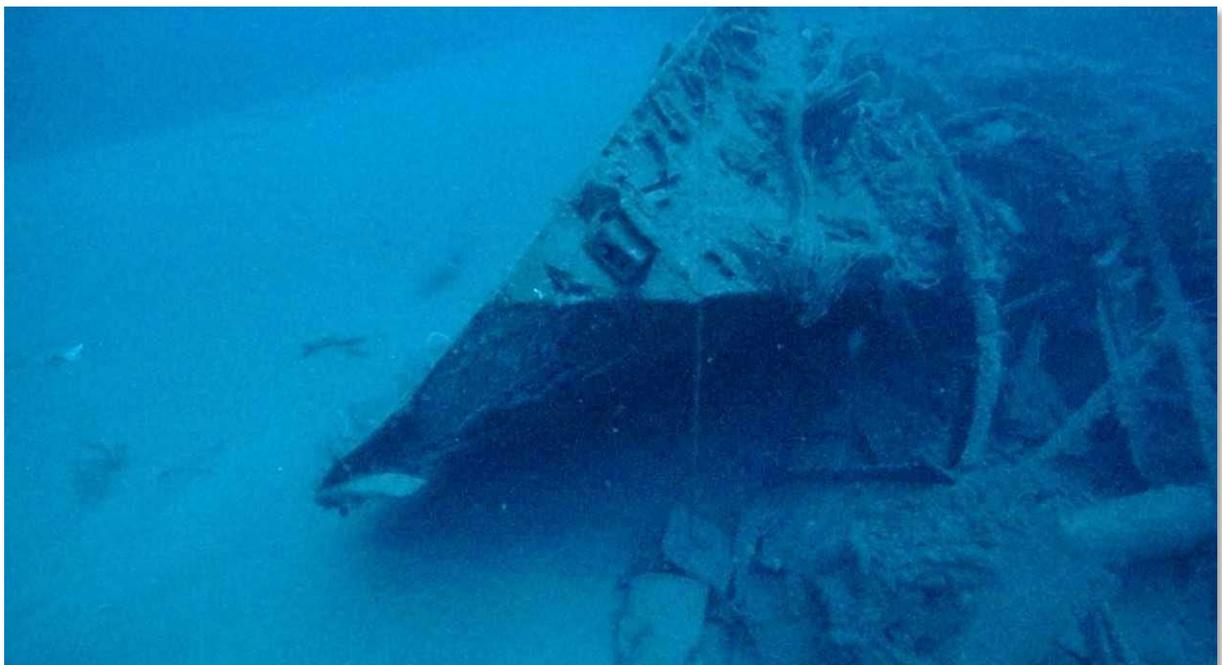
Figure 30: Bow of the *Wollongbar* (II) from the port side. Note the stem has been peeled off leaving only a “U” section girder (Image: AUS ROV 2019)

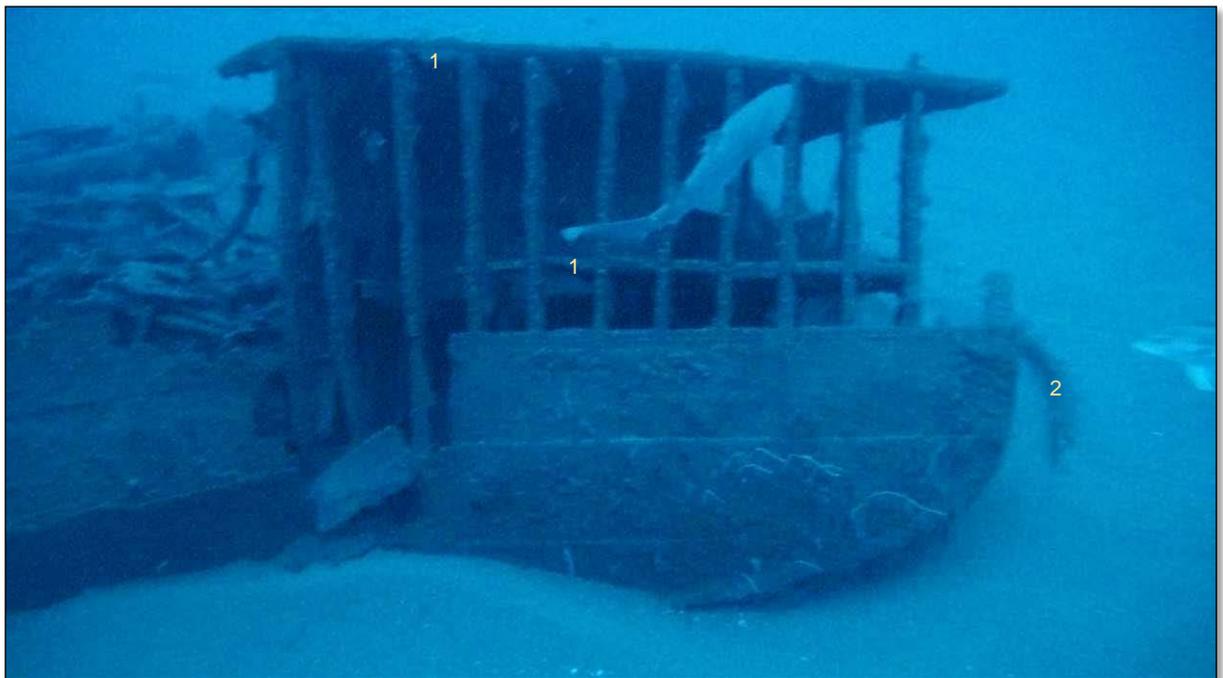
Figure 32: Bow showing loss of hull plating and stringers/ lugs (1) and lack of evidence of the hawse pipe. Note the stem (2) has been peeled off on the extreme right (Image: AUS ROV 2019)

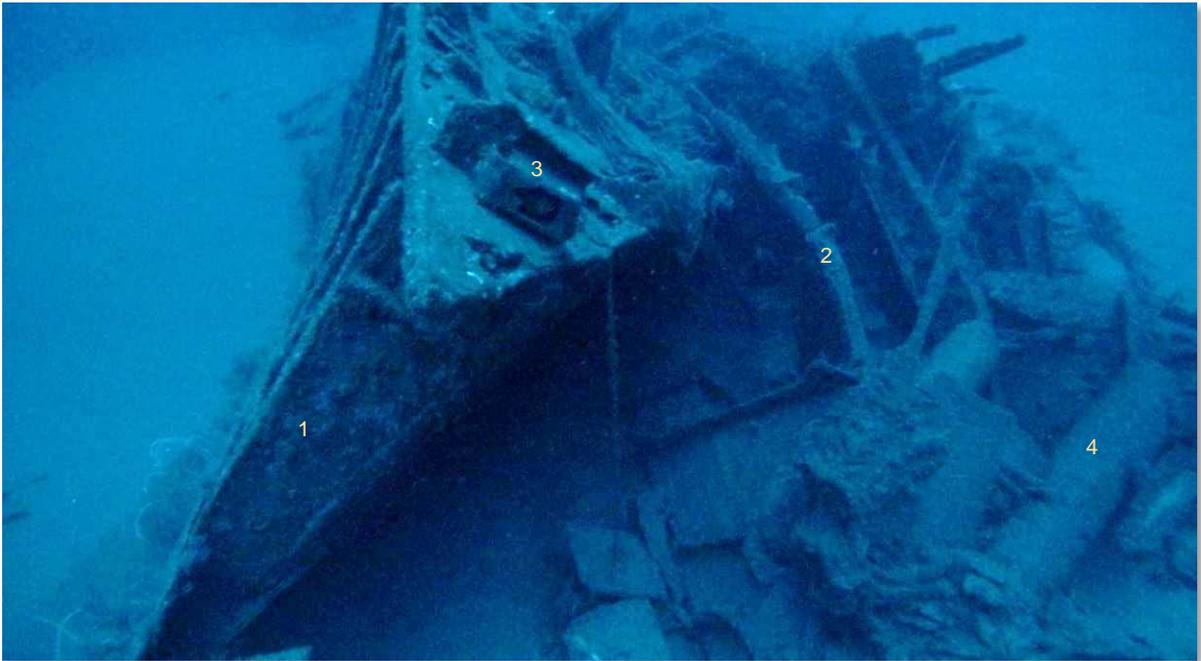
**Figure 33: Bow showing detached stem post/ channel bar (1), collapsed focse frames (2), possible navigational running light (3); and detached hawse pipes and/ or ventilator tubes (4) (Image: AUS ROV 2019)**

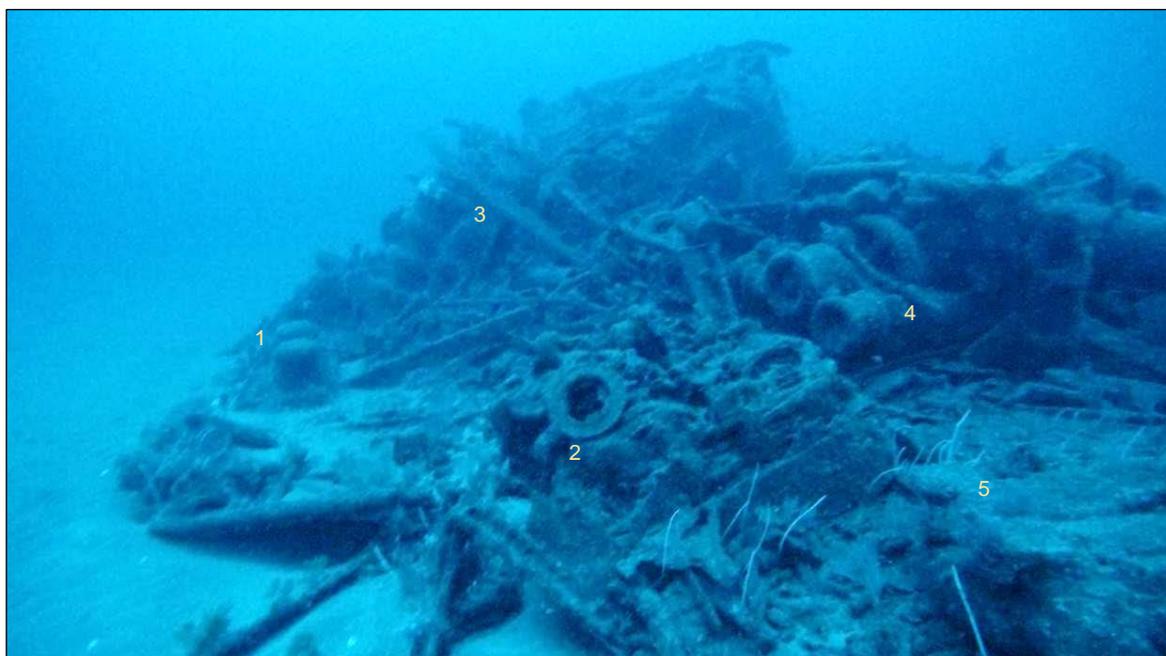
Figure 36: View of collapsed foredeck at bow from aft, showing bitts (1), boatswain's locker box of spares (2), windlass (3), derrick winch (4) and anchor (5) (Image: AUS ROV 2019)

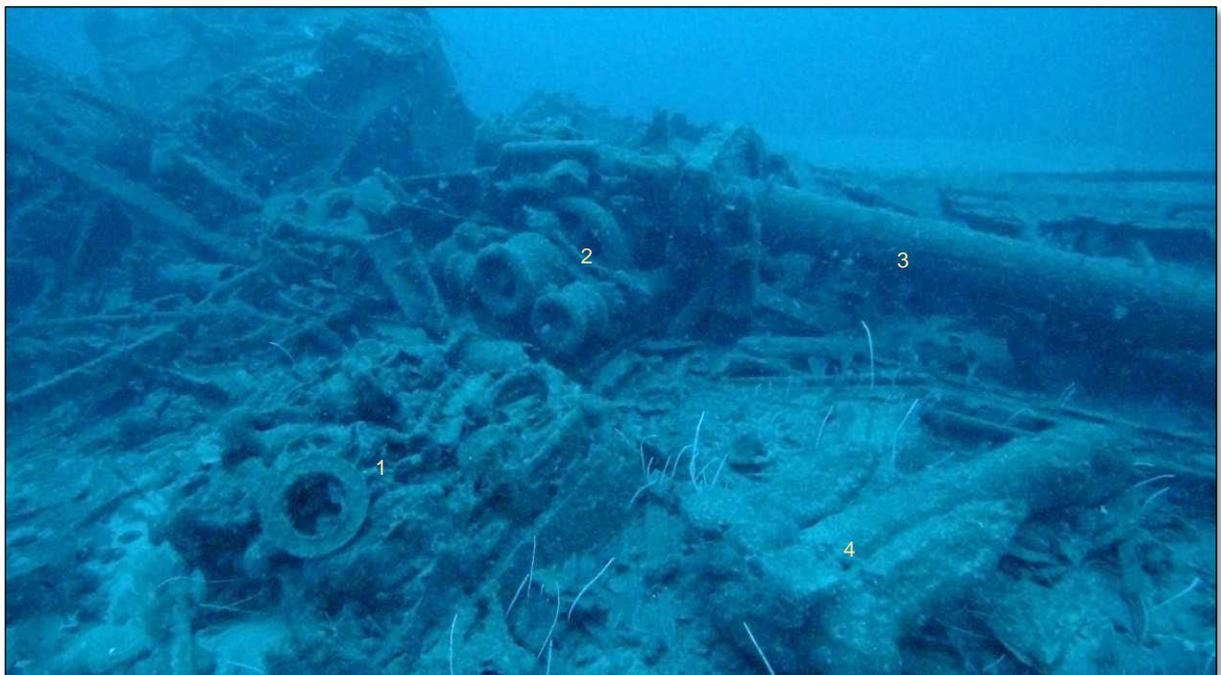
Figure 38: Bow showing collapsed foredeck with locker box of spares (1), derrick crane winch (2), derrick crane mast (3) and anchor (4). Note porthole in middle of the box which is probably storage box associated with the foredeck locker and/or boatswain's locker (Image: AUS ROV 2019)

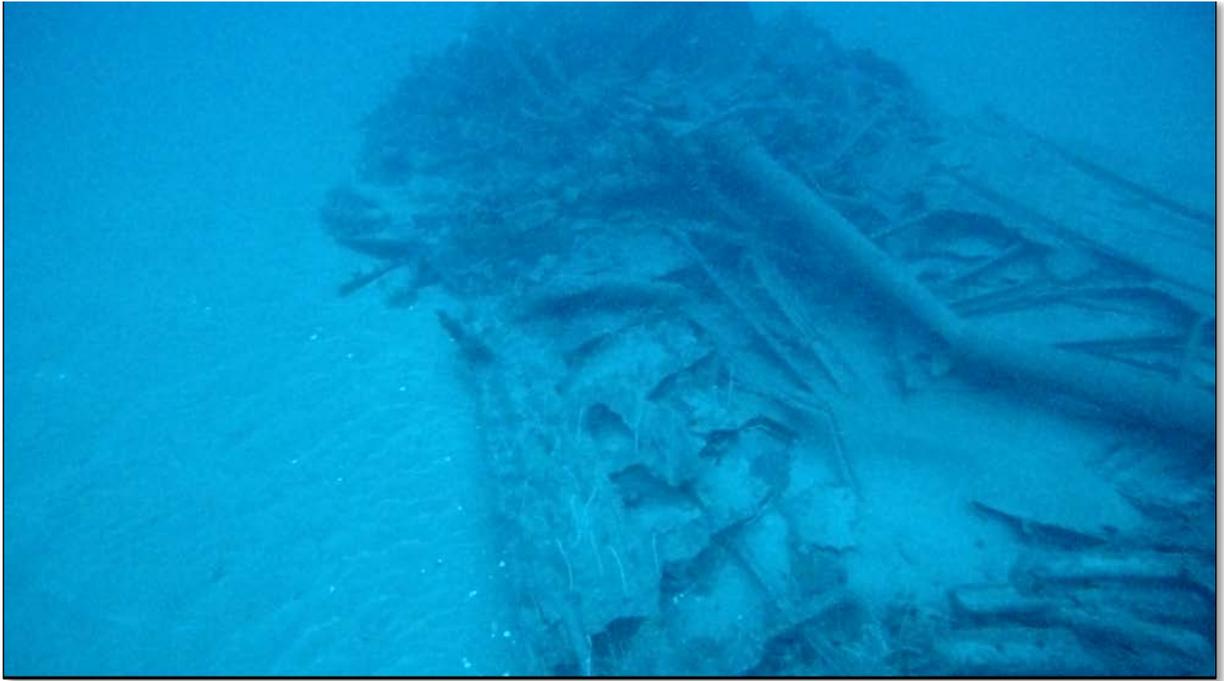
Figure 46: Bow section facing forward. Note the collapsed derrick crane post lying across the winch area, and the flattened section of hull aft (Image: AUS ROV 2019)

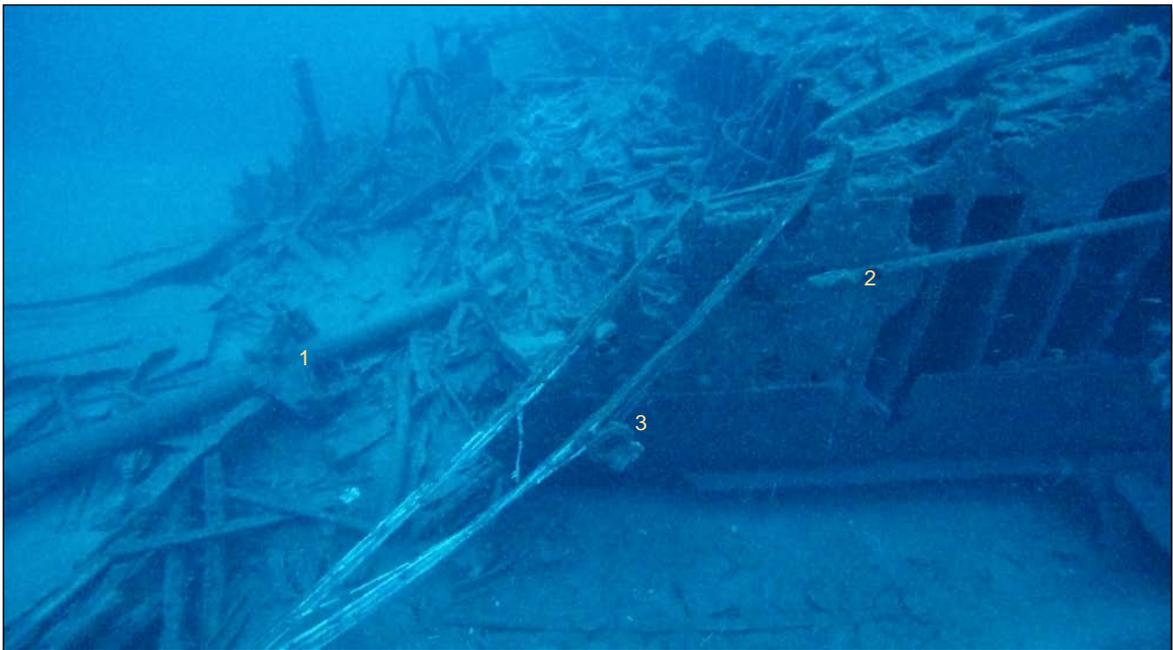
**Figure 48:** Collapsed section of hull just aft of the bow, showing collapsed forward derrick crane post and cheeks (1), and section of the rubbing strake (2) on the port side, and detached strakes with porthole attached (3) (Image: AUS ROV 2019)

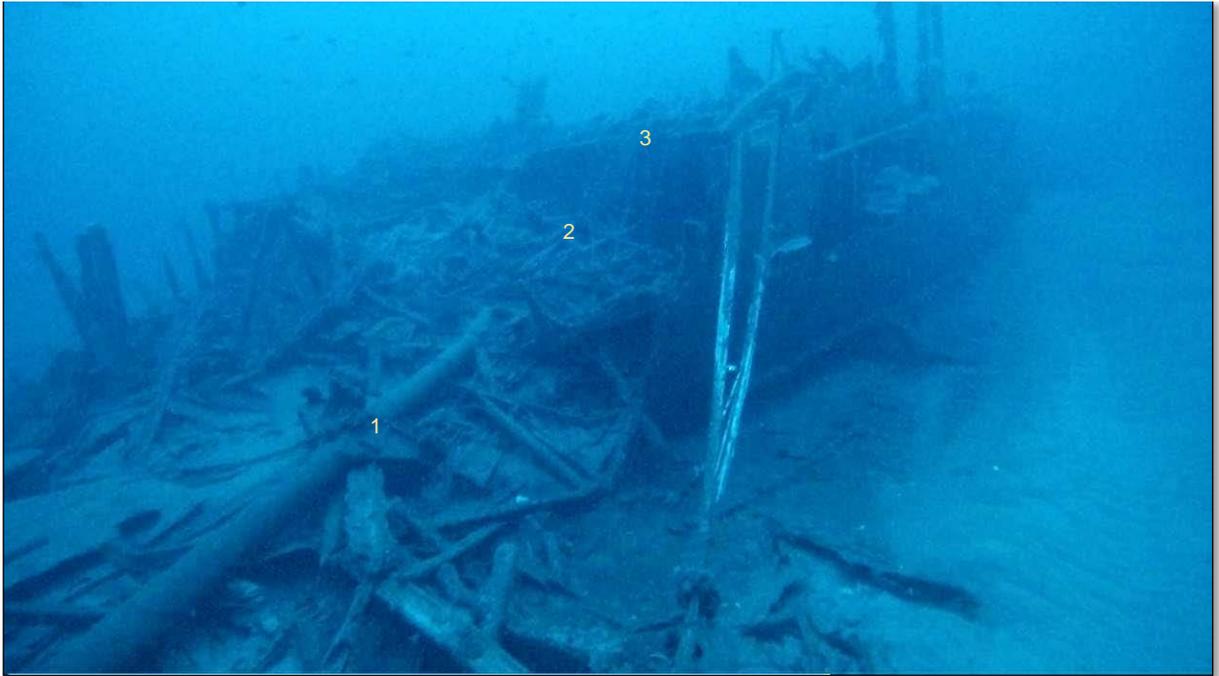
**Figure 49:** Area of substantial damage in area near former bridge structure. Note: the derrick crane mast cheeks (1), the remnants of the main deck under the mangled wreckage (2), and promenade deck (3) (Image: AUS ROV 2019)

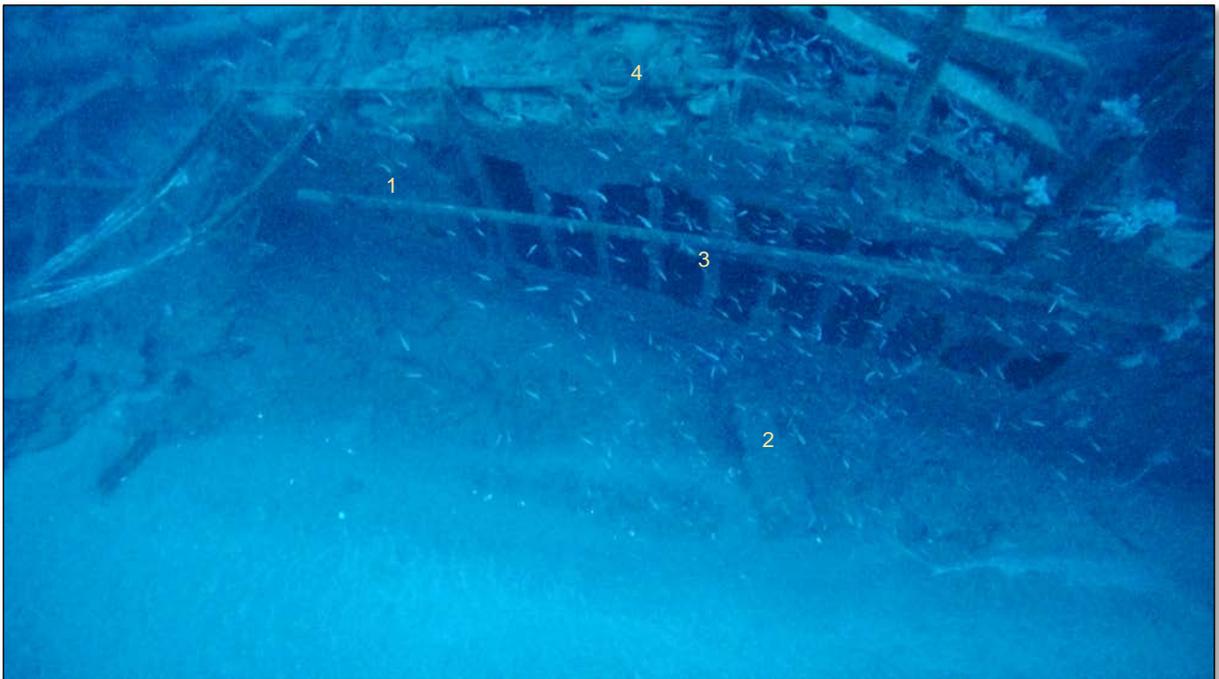
**Figure 50:** Amidships section in vicinity of the former bridge showing detached rubbing strake (1) and detached hull plating (2) exposing underlying frames (3). Note porthole (4) lying on top of the collapsed hull just inside the vessel (Image: AUS ROV 2019)

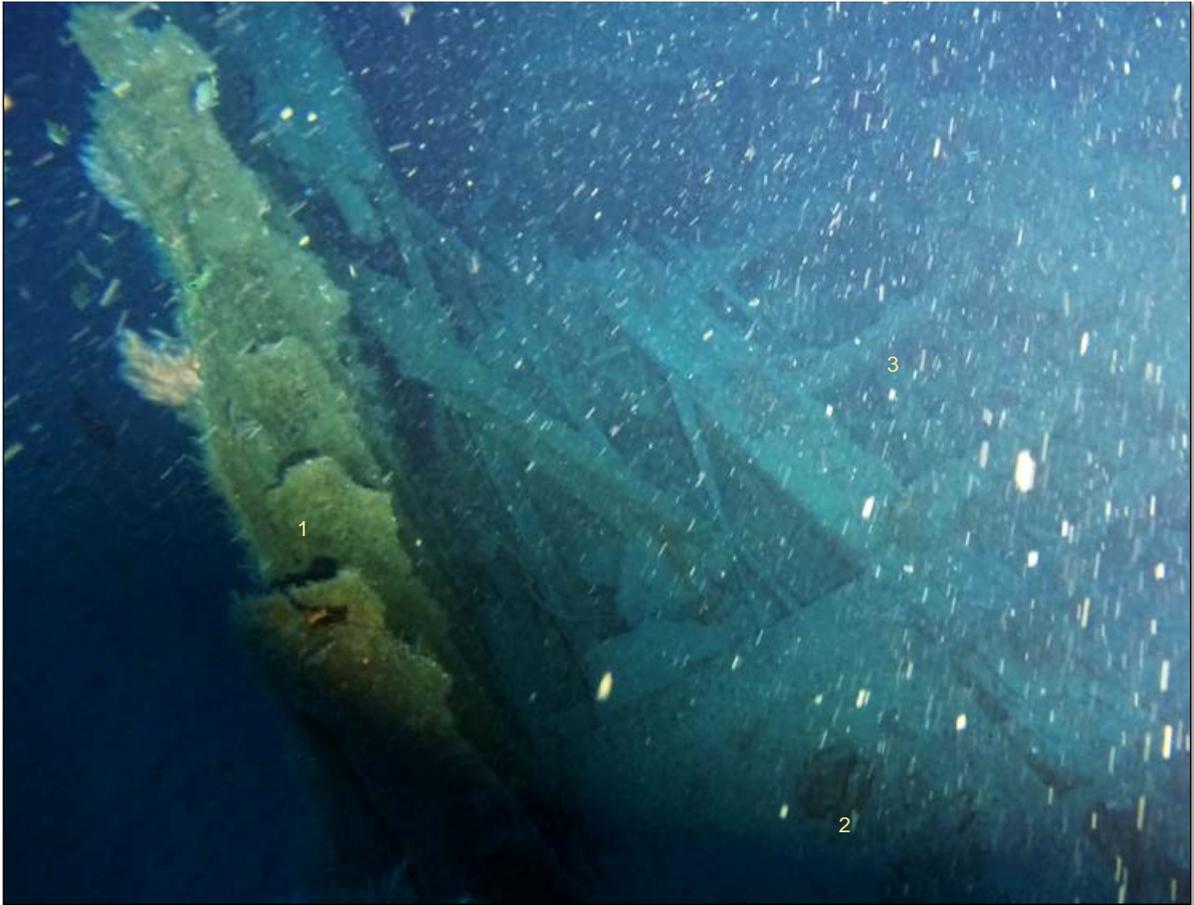
Figure 51: Broken frames on the port amidships side (1), showing collapsed hull plating with intact portholes/scuttles resting inside the hull and deck beams (3) (Image: AUS ROV 2019)

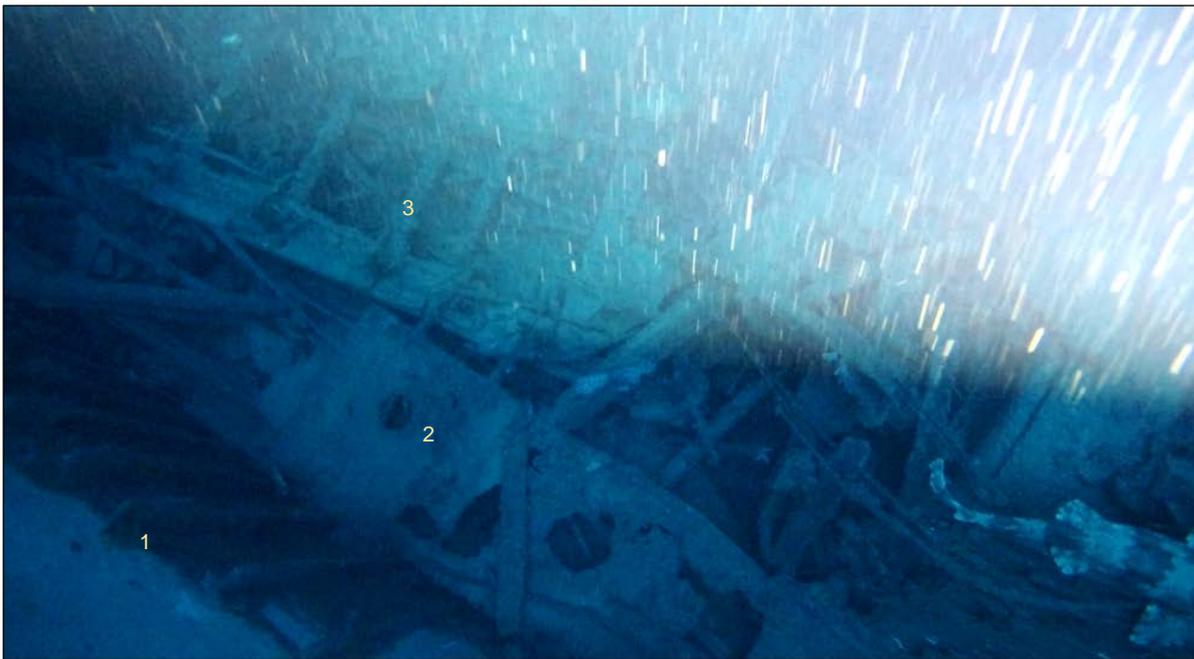
Figure 52: Broken frames on the port amidships side (1), showing collapsed hull plating with intact portholes/ scuttles (2) resting inside the hull. Note what appears to be deck beams (3) in top left corner of image (Image: AUS ROV 2019)

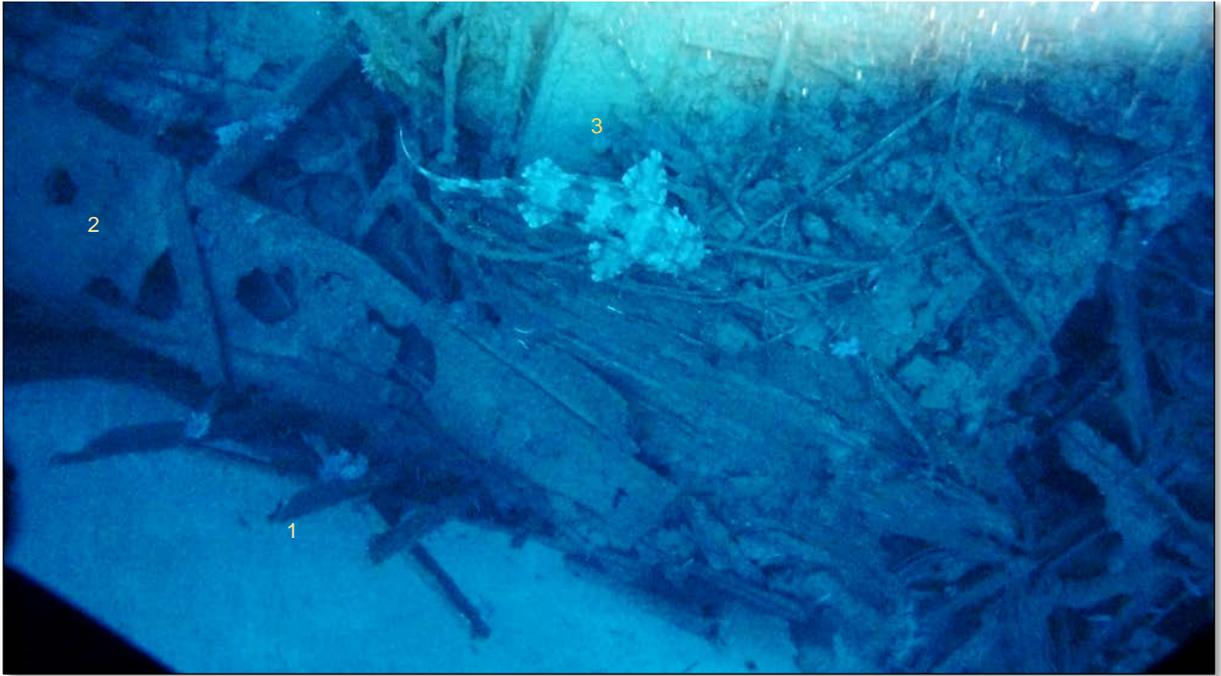
**Figure 53: Broken frames (1) on the port amidships side, showing collapsed hull plating with intact portholes/ scuttles (2) inside the hull. Note what may be the remains of the forward end of the boiler (3) just above the wobbegong shark (Image: AUS ROV 2019)**

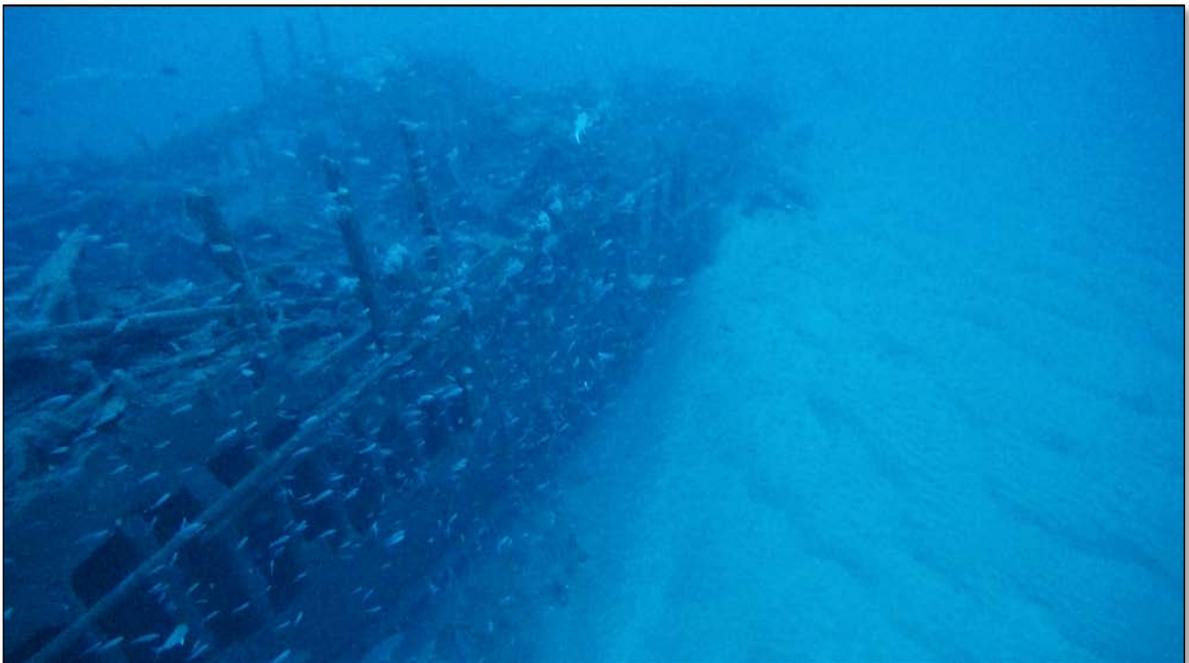
**Figure 54: Aft end of amidships section of wreck, showing second area of explosion damage (Image: AUS ROV 2019)**

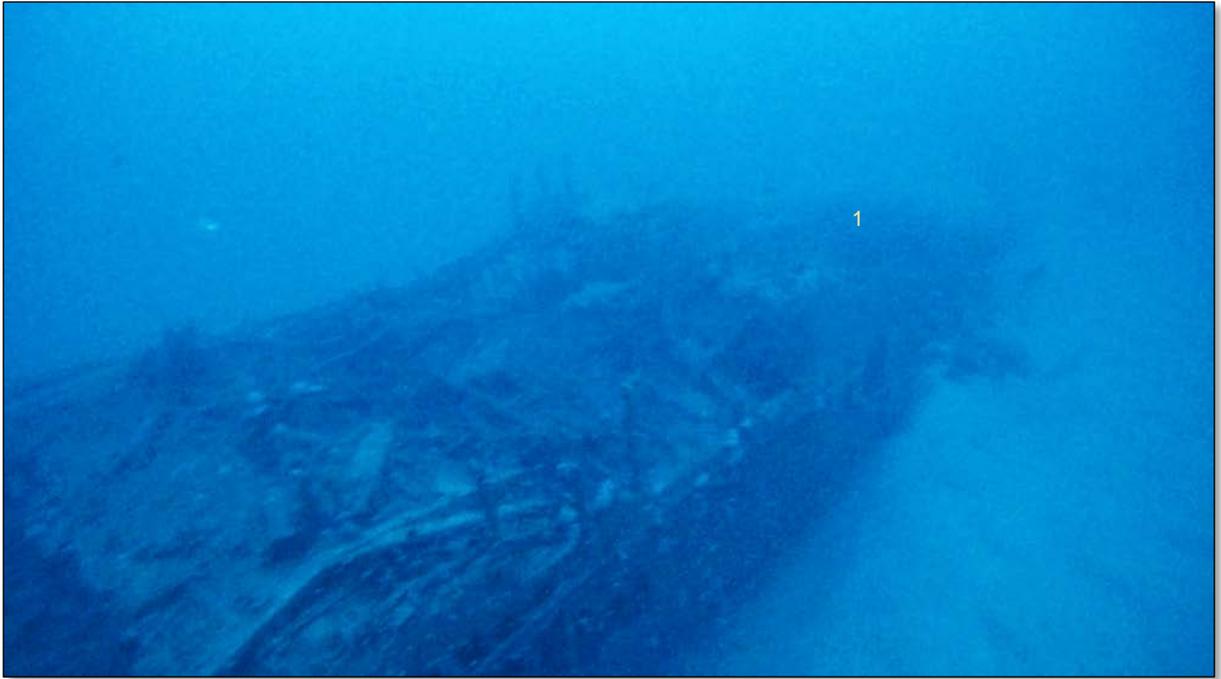
**Figure 55: Aft section of midships showing area of probable explosion damage (1) in the engine room area (Image: AUS ROV 2019)**

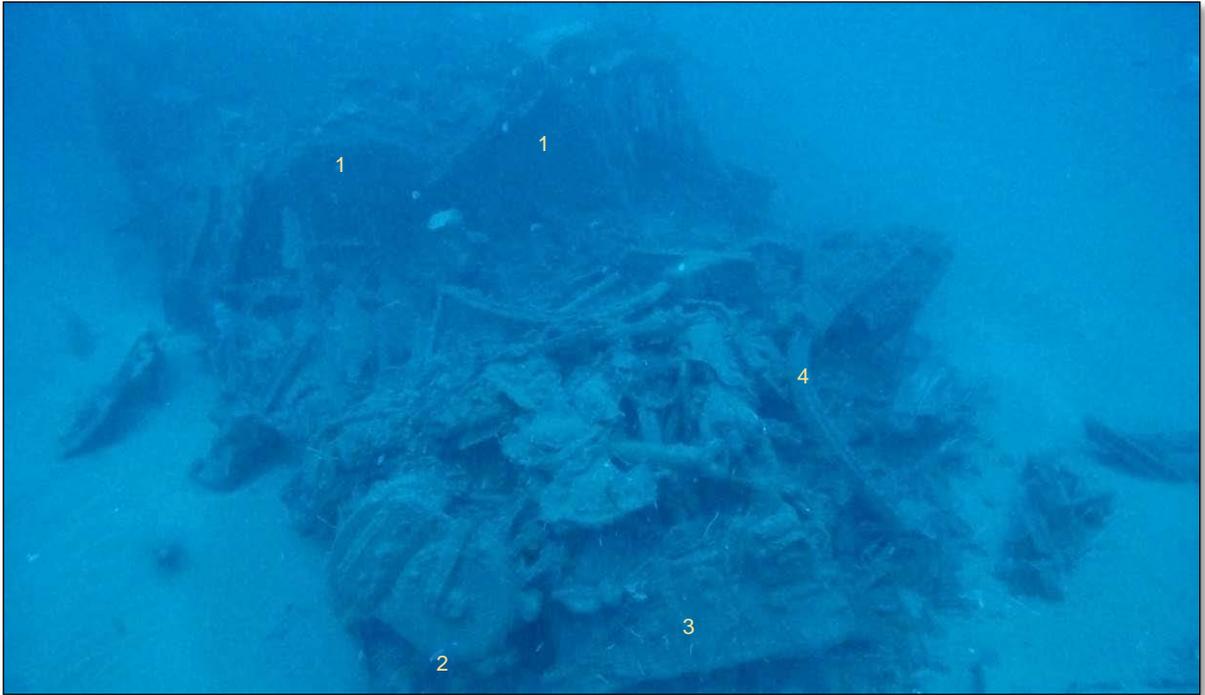
**Figure 58: View of collapsed aft section showing boiler (1), steam engine low pressure cylinder and tail rod (2), medium and high pressure cylinders (3) and lifeboat davits (4) (Image: AUS ROV 2019)**

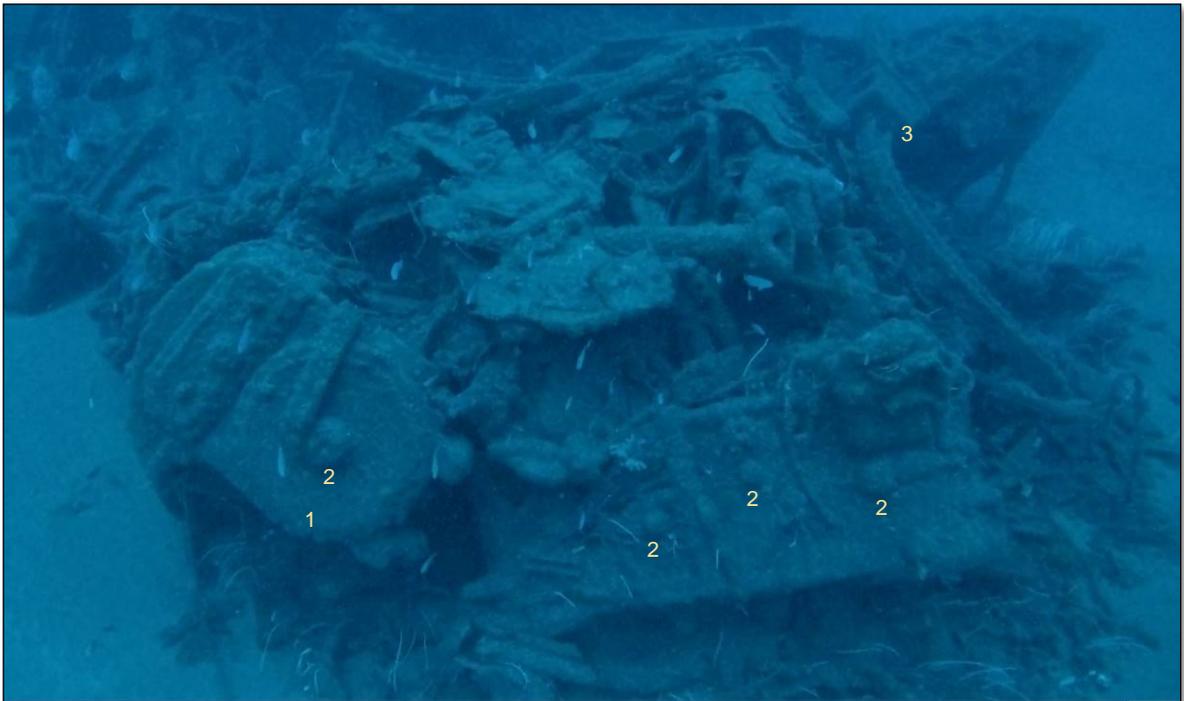
**Figure 59: Closeup view of collapsed steam engine showing low pressure cylinder cover and tail rod (1) and tail rods (2) on main engine, which is perpendicular to its original position on head and broken section of the main engine. See also lifeboat davits (3) and engine pipes (Image: AUS ROV 2019)**

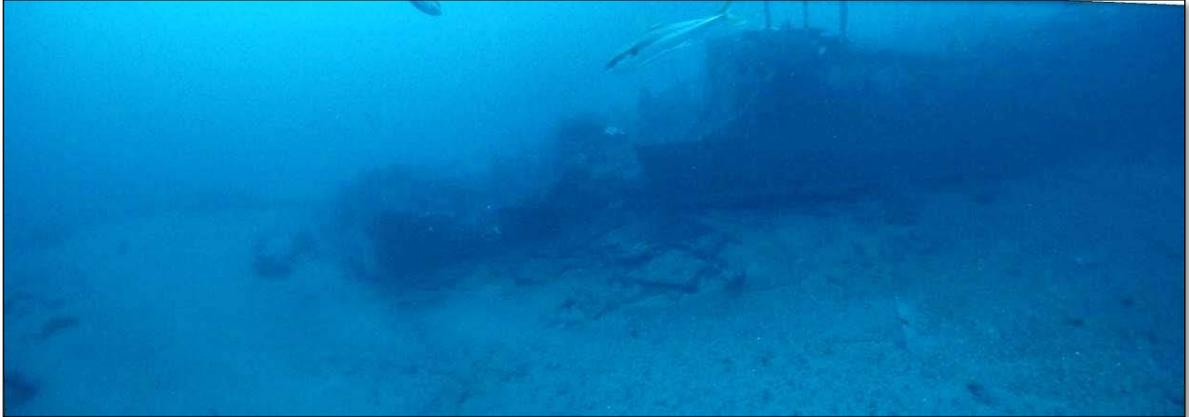
Figure 62: Starboard aft side of amidships section, showing extent of explosion to the vessel (Image: After AUS ROV 2019)

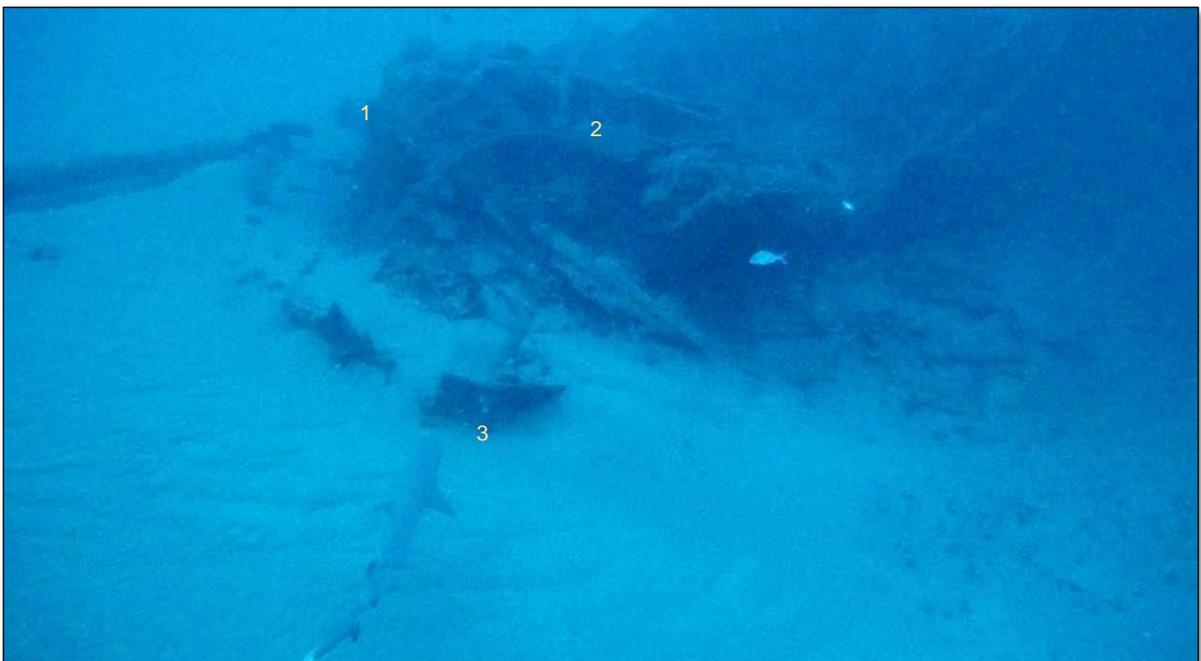
Figure 63: View of aft amidships section from starboard side, showing engine (1) and davits (2) area. Note the lack of any visible structure aft of this area, square structure with pipe extending from top and grey nurse shark in the foreground and crane mast/derrick on left top (Image: After AUS ROV 2019)

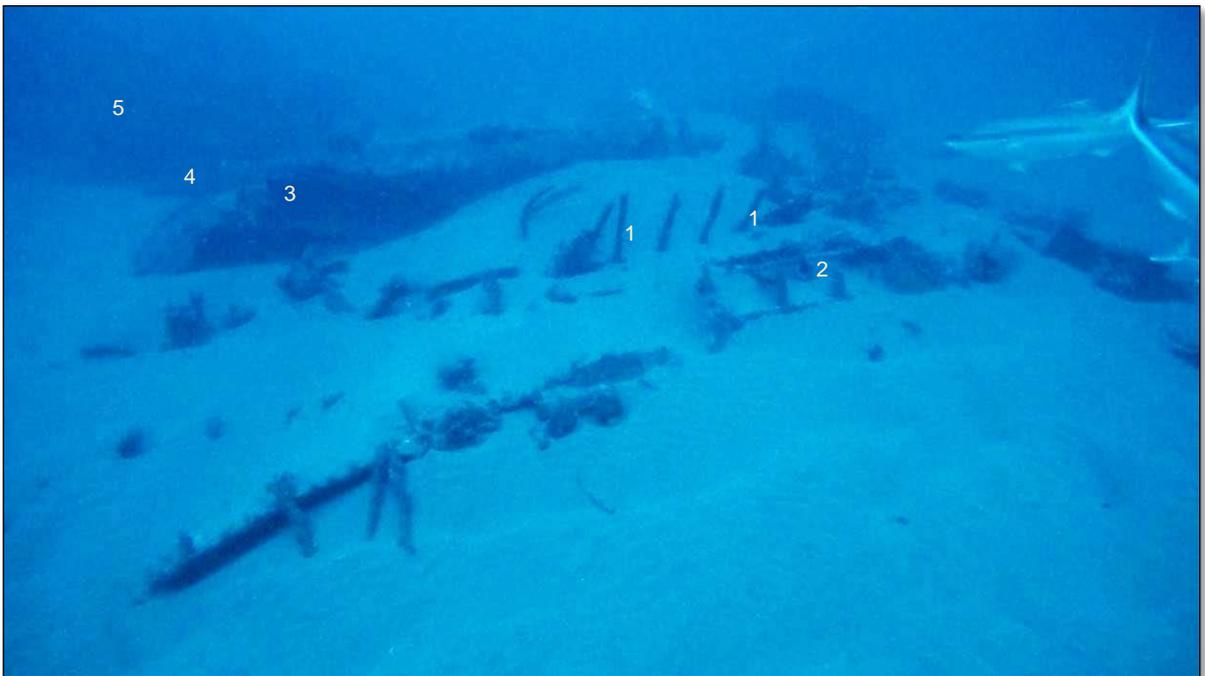
Figure 72: Extreme northern end of wreckage facing south. Note the frames (1) running athwart the direction of the main wreck site and the porthole (2) behind the upright frames. In background is the possible drive shaft tunnel or bent hull plating (3); the derrick crane mast (4) and engine room debris (5) (Image: After AUS ROV 2019)

broken off during an explosion, and has been deposited at a 90 degree angle to the main wreck site after the vessel has settled on the seabed.

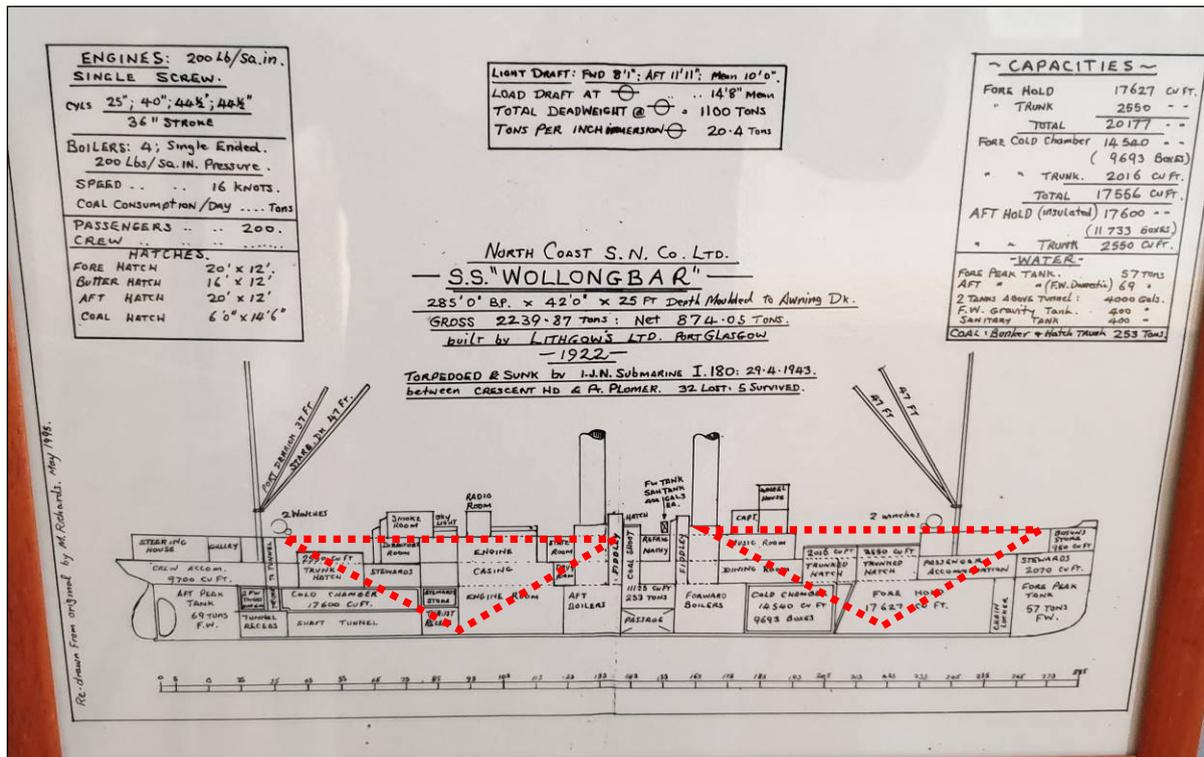
Figure 88: Vessel Plan of the *Wollongbar* (II) based on original held by Mike Richards at Mid North Coast Maritime Museum, showing the probable blast radius of the torpedo explosions in red (Image: Brad Duncan, Heritage NSW 2019)

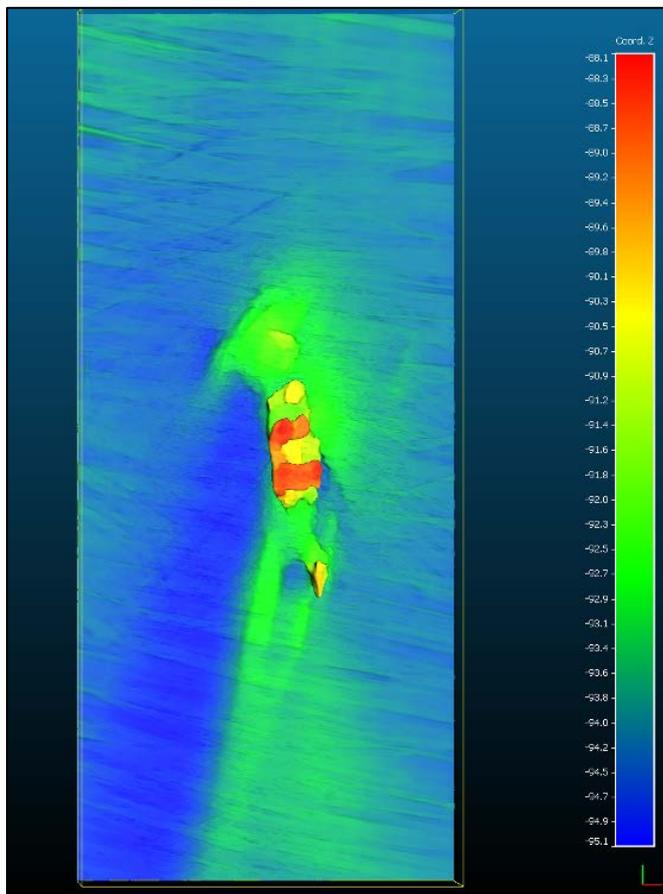
Figure 89: Multibeam image of *Wollongbar (II)* site showing sand accretion and scouring across the wreck (Image: AUS-ROV 2019)
