# ***Wollongbar (II) Shipwreck Inspections 2019 Off Crescent Head, NSW***

**By: Dr Brad Duncan**  
**Senior Maritime Archaeologist, Specialist Services Team**  
**Heritage NSW**  
**Department of Premier and Cabinet**

**Report Prepared by Dr Brad Duncan:** August 2020, revised April 2021.

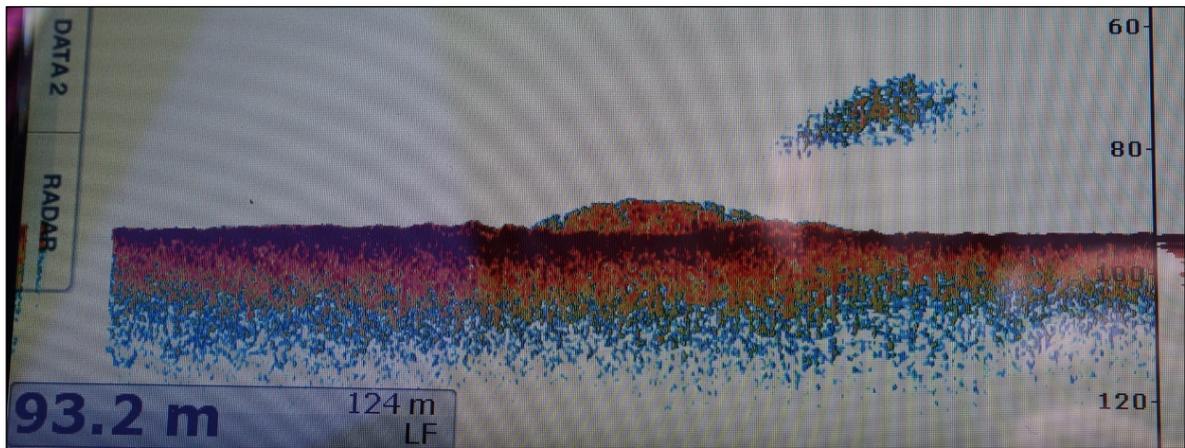
The location of the second set of marks provided proved to be 100% accurate. Initial onsite inspection of the site revealed two sections of the wreck which appeared to be lying in a line, suggesting that the wreck has collapsed in the midships section. Initial measurements of the site based on echo sounder readouts indicated that the wreck was approximately 80 m long x 13 m wide (Figure 25). The northern section of the wreck stood about 6m above the seabed, with either a bait ball of fish or possibly a net evident from the 65-80m mark above the wreck (Figure 26). A strong current was observed on the site, running roughly north to south, and up to 5 knots.

Figure 25: Echo sounder image of the site north to left of image (Image: Brad Duncan, Heritage NSW 2019)

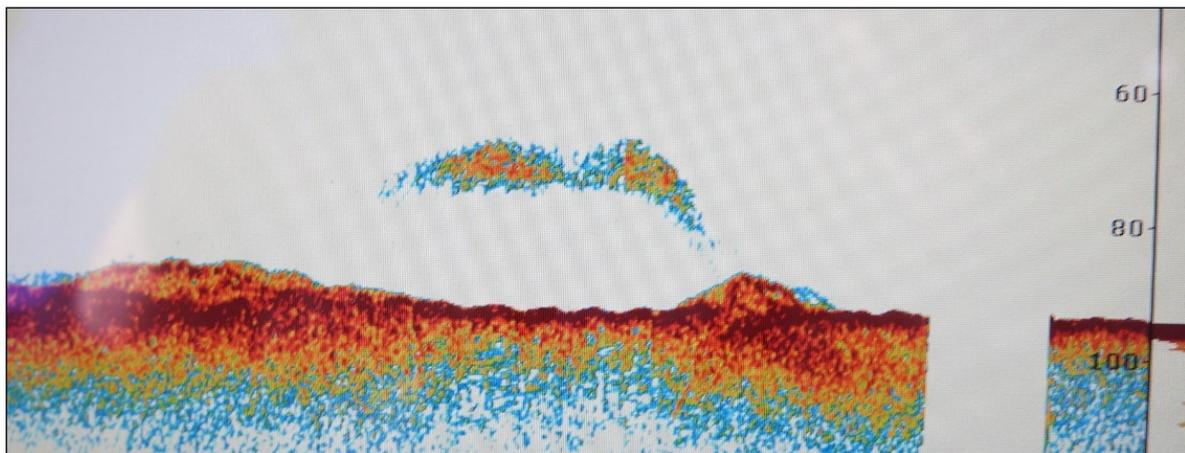
Figure 26: Echosounder view of wreck. Left side travelling north to south and then side view from south as the boat turns around. Note the bait ball or possible net hovering at approx. 65-80m mark above the site in a southerly direction (Image: Brad Duncan, Heritage NSW 2019)

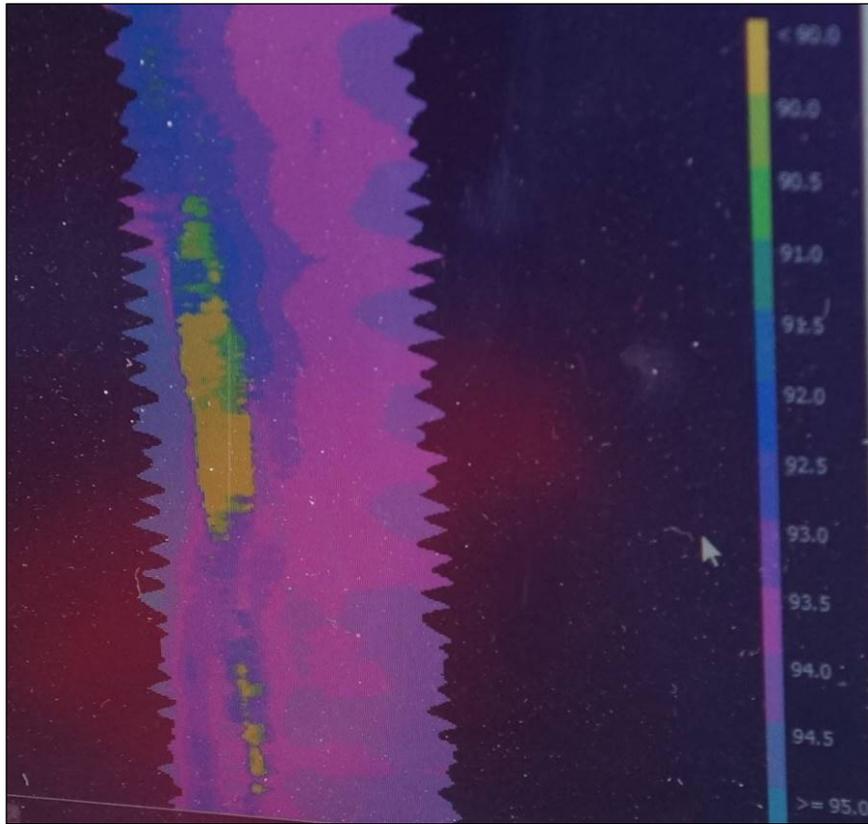
Figure 27: Initial multibeam survey results of the site, north at the top of the image (Image: Brad Duncan, Heritage)

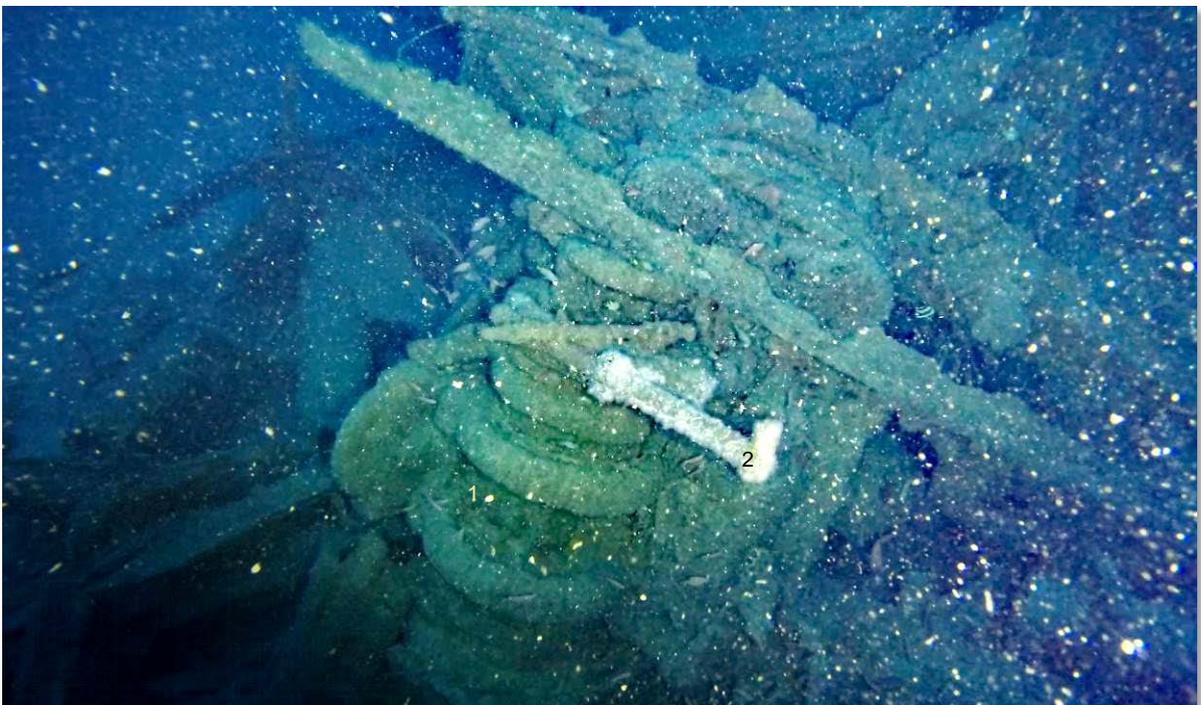
A windlass is located just aft of the hawseholes/ventilator tubes on the port side of the bow. It consists of at least one set of cable lifters, 1 set spur wheels, and a brake wheel handle (Figure 34). This is most likely a steam windlass that would have been mounted on the foredeck of the forecastle, as shown in Figure 35.

**Figure 34: Windlass, showing the cable lifters (1) brake wheel (2) (Image: AUS ROV 2019)**

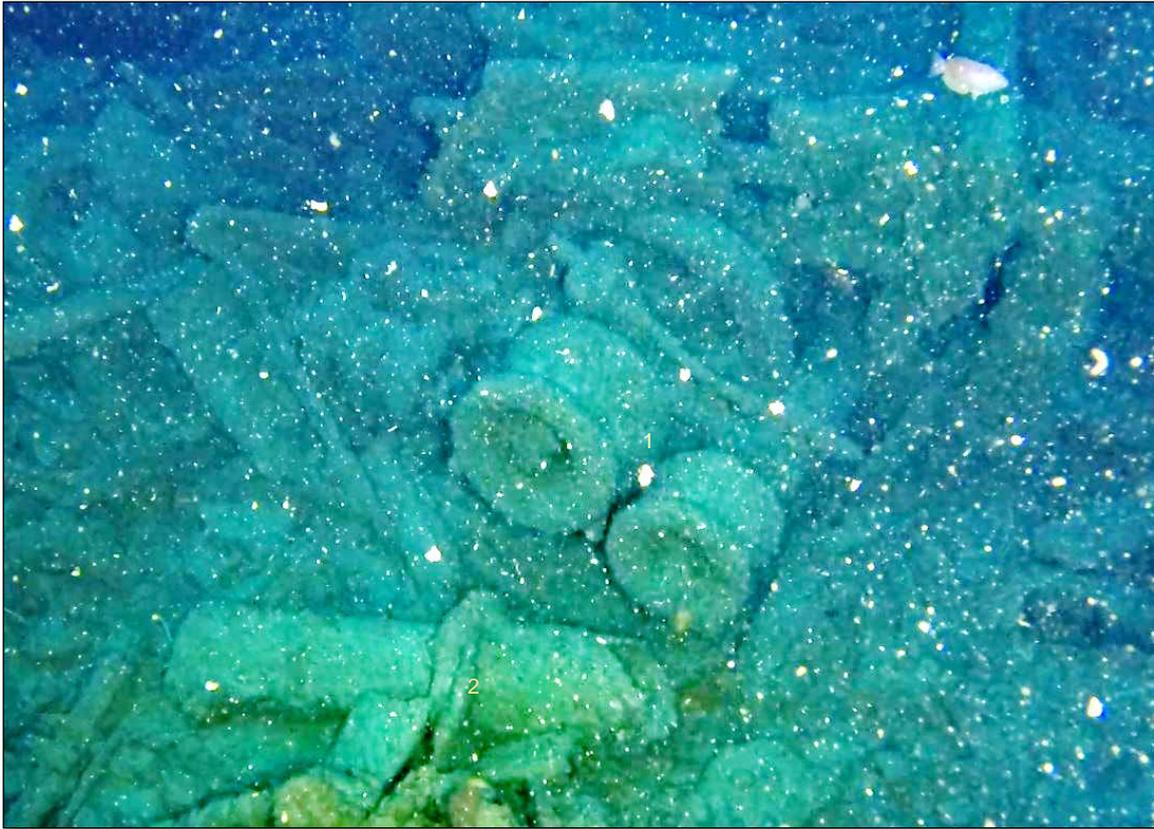
The remains of what is probably the forecastle or focsle deck lie scattered on top of and adjacent to the intact main section of the bow on the port side (Figure 36). Figure 37 shows a historical model of comparable foredeck setup. The remains of a winch with two warping ends and a pinion wheel is located just aft of the intact bow section. It lies partially under a collapsed mast or derrick crane (Figure 38). The remains of what is probably a ventilator tube lie almost beneath the warping ends of the winch (Figure 39). Figure 40 shows a historical representation of a steam winch.

Figure 39: Steam derrick winch (1) and ventilator tube (2) (Image: AUS ROV)

The configuration of the foredeck furniture and the presence of the forward derrick crane on the foredeck is consistent with the SS *Wollongbar* (II) half model (Figure 76). The wreck has a plumb bow (Figure 32), with evidence of a collapsed foredeck with bitts used for mooring (Figure 45), a stockless style anchor - possibly of the Byers patent design (Figure 43), a possible steam winch (Figure 39) used to operate a derrick which was probably mounted on or close to the foredeck.

The fittings on the derrick cranes (Figure 65, Figure 66), along with the steam windlass (Figure 34) and derrick crane steam winch (Figure 39) found on the wreck are all consistent with those features shown on the half model of the *Wollongbar* (II) - (see Figure 80, Figure 81, and Figure 82) respectively.

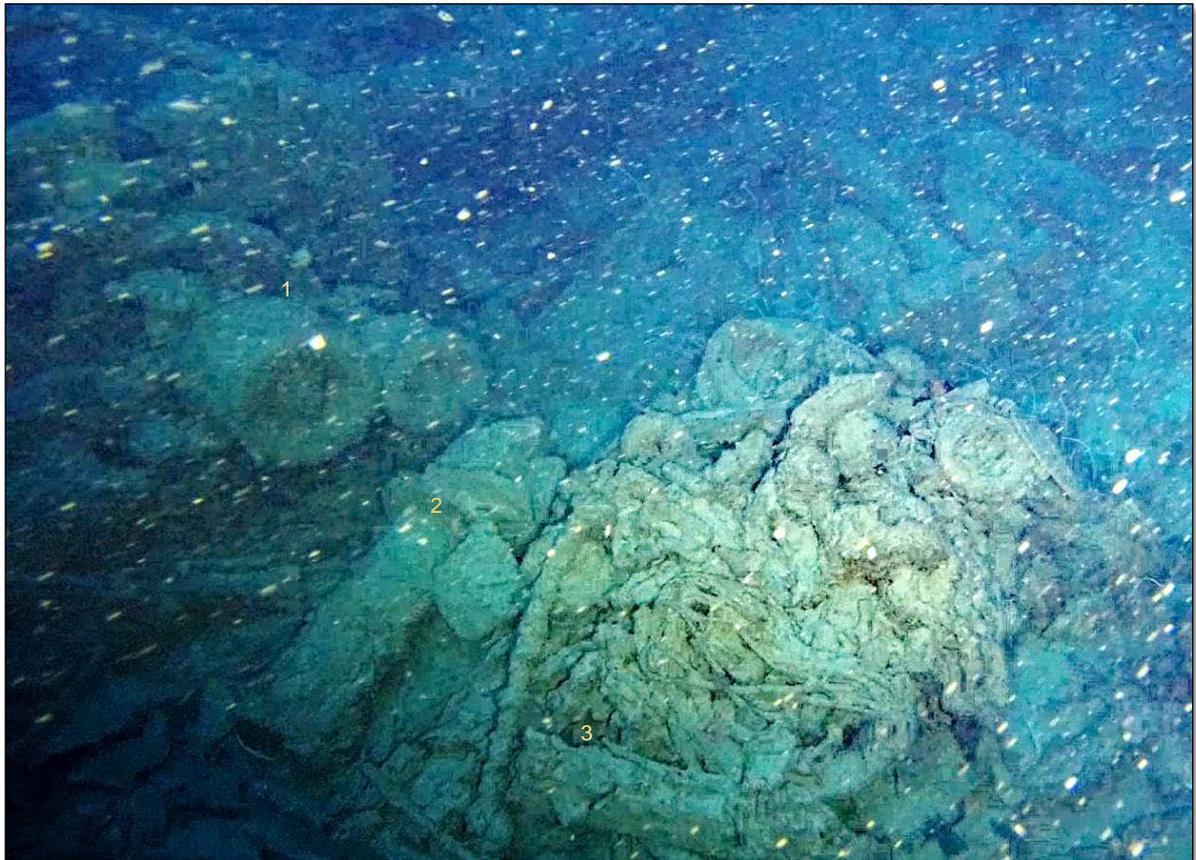
Directly to the east of the of the warping ends of the winch is the outline of a square structure with the remains of miscellaneous materials, including what appears to be a porthole, and possibly wire and chain (Figure 41). This may be a box associated with

operation of the winch or storage of day to day items/ spares below the foredeck for use as required, or may be a box from the bosuns locker.

Figure 41: Winch (1), ventilator (2) and remains of bosun's locker equipment box (3) with cable chain and portholes (Image: AUS ROV 2019)

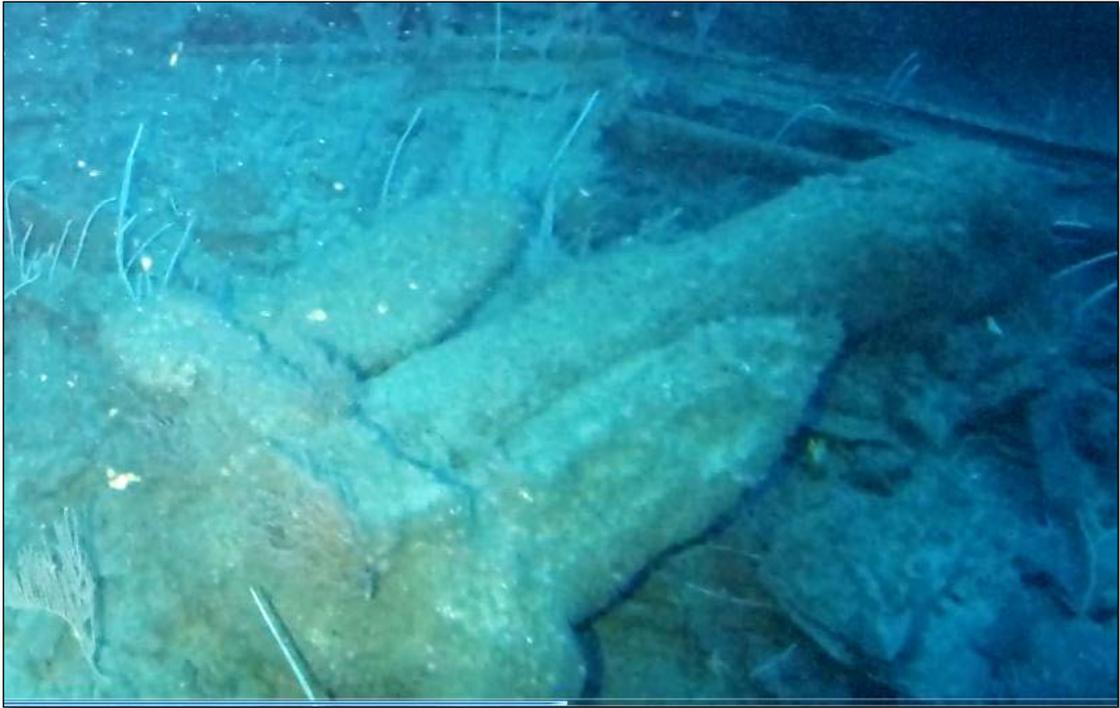
Figure 43: Stockless anchor at bow (Image: AUS ROV 2019)

A stockless anchor (Figure 43), possibly of the M.A.F. Patent or Byers type (W. L. Byers and Co n.d. – see Figure 42, Figure 44), lies directly to the north of the this feature.

If the stockless anchor (Figure 43) is a Byers Patent, this is consistent with the period when the *Wollongbar* (II) was constructed, and conforms to the anchor on the half ship's model of the vessel located at the Mid North Coast Maritime Museum at Port Macquarie (Figure 79), and with the historic images of the vessel.

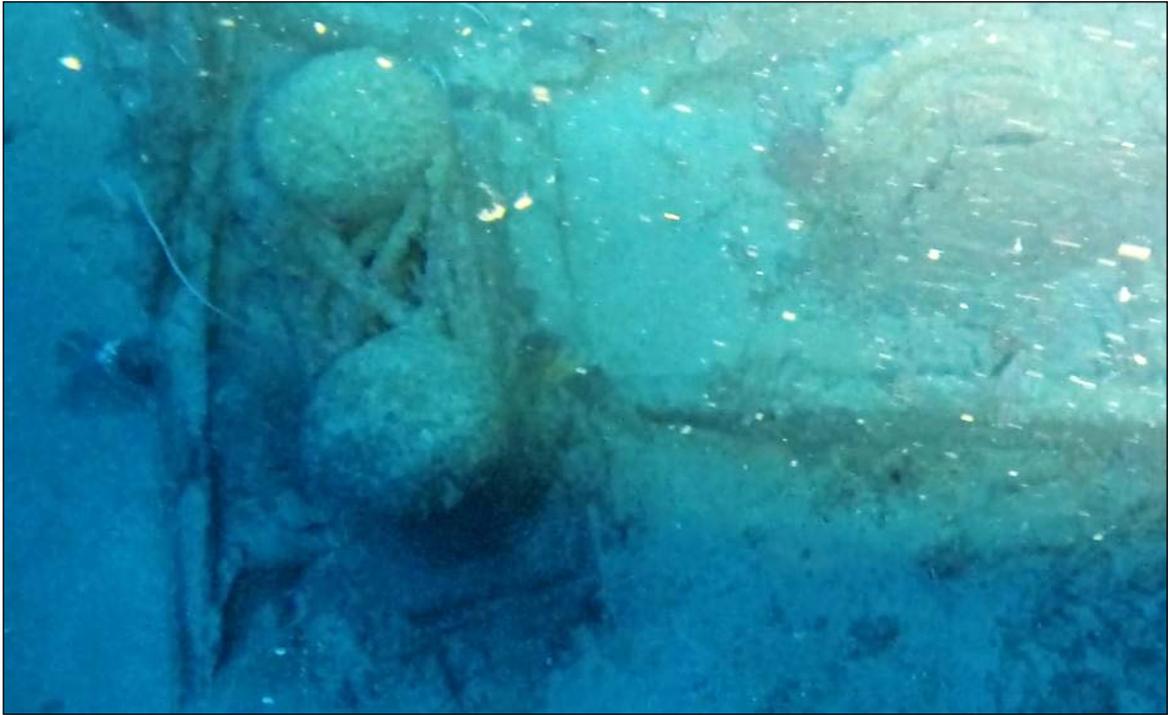
A set of bitts with rope still wound around the uprights is located on the port side periphery of the collapsed foredeck (Figure 45).

Figure 45: Bitts with rope attached from foredeck (Image: AUS ROV 2019)

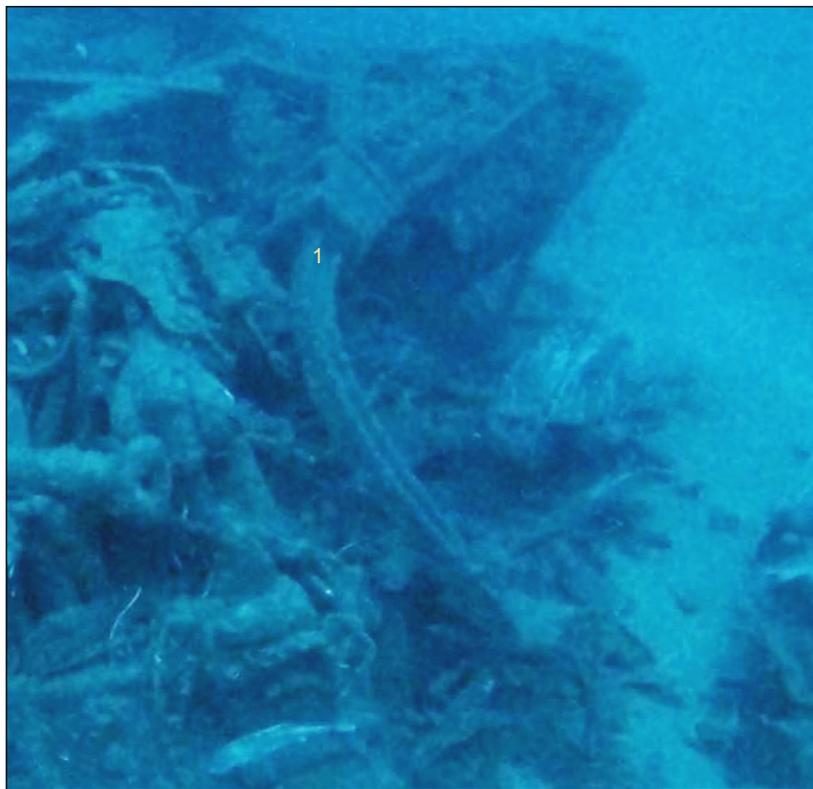
There were several lifeboat davits located in the area between the boiler and the engine on the starboard side (Figure 61). The davits have the typical curved arms to support the falls for the lifeboat but have an unusual square sided pedestal base.

Figure 61: Lifeboat Davit (1). Note engine and steam pipe parts on bottom left of picture (Image: AUS-ROV 2019)

Two lifeboat davits visible at the stern/ engine section of the wreck (Figure 61) are identical in design to those on the *Wollongbar* (II) model (Figure 83). The lifeboats shown in the model are located close to the aft funnel, indicating that they were located behind the boiler, which is consistent with the location of the davits observed on the wreck.

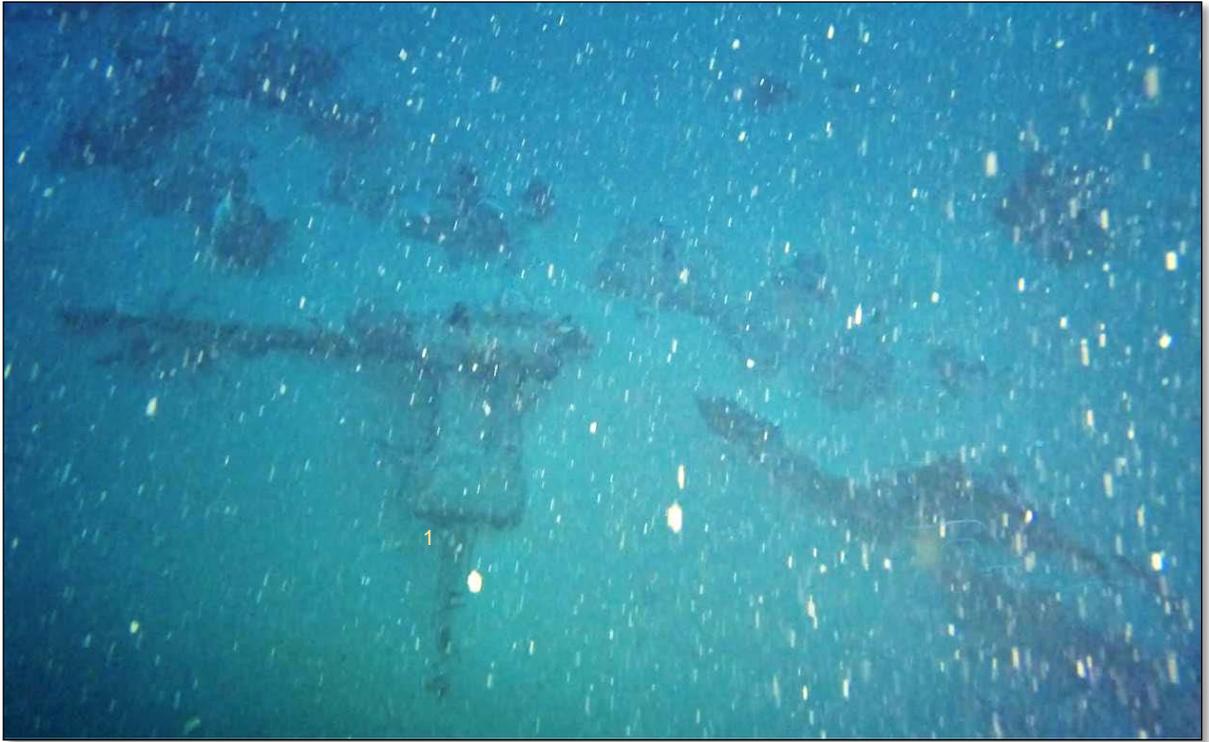
The starboard side of the wreck is also deteriorated along the blast area and the hull plating has collapsed outwards to the starboard of the engine and lifeboat davit area (Figure 62). A large box like structure with a protruding pole or pipe is located to the aft starboard of the engine (Figure 63). A pedestal like structure is located aft of this area on the starboard side, and may either be the base of a winch, capstan or mount (Figure 64).

**Figure 64: Unidentified deck furniture (1) on starboard side of the vessel facing east, just outside the hull line and just aft of the engine/ explosion area, which could be a capstan, gun pivot mount or winch? (Image: After AUS ROV 2019)**

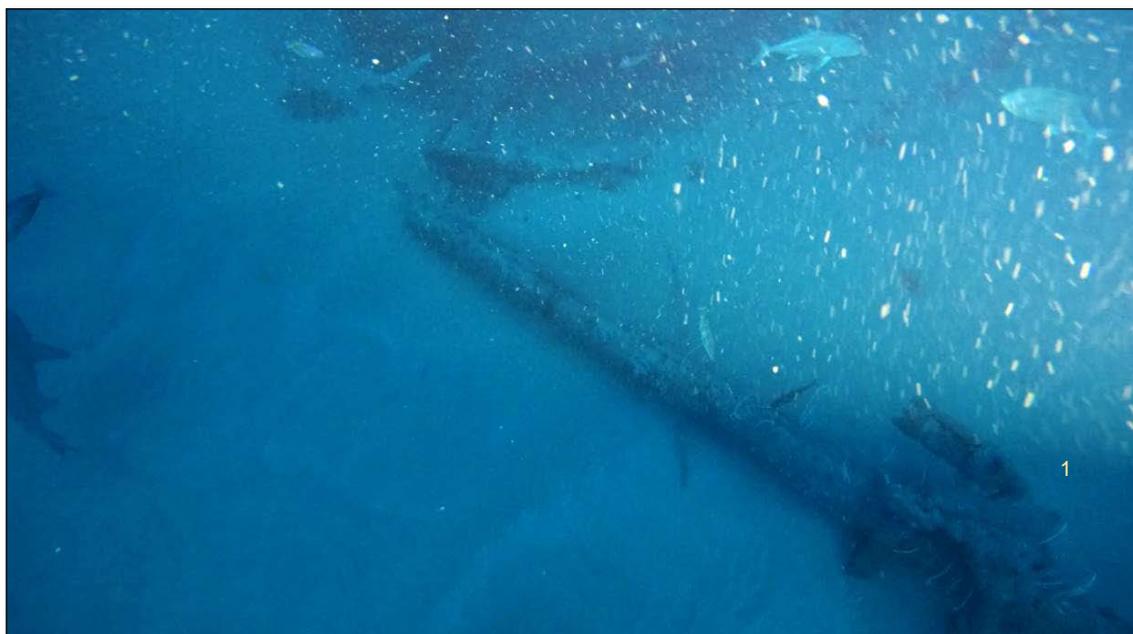
A mast or derrick crane boom (Figure 65) runs from close to the base of the engine on the port side diagonally across the site towards the stern. It is tapered at the forward end and has what is probably rigging tackle (Figure 66, Figure 67) associated with a derrick crane boom at its root. Based on these observations it appears to have been mounted towards the stern. It lies across another section of crumpled hull plating, possibly from the upper hull, or alternatively from the driveshaft tunnel (Figure 68), as there is a pipe with a flange which may be part of the driveshaft for the propeller (Figure 69). Figure 70 shows a typical configuration of stern driveshaft in a coastal freighter from the 1930s. This feature is oriented perpendicular to the main wreck site, as is another section of crumpled hull plating (with portholes) and upright broken frames (Figure 71). These features suggest that the stern of the vessel may have partially detached as a result of the explosion, and may lie perpendicular to the longitudinal orientation of the main wreck site.

**Figure 65: Derrick mast facing south. Note the rigging tackle of the lifting tackle/apparatus (1) still attached at the bottom right of the image (Image: After AUS ROV 2019)**

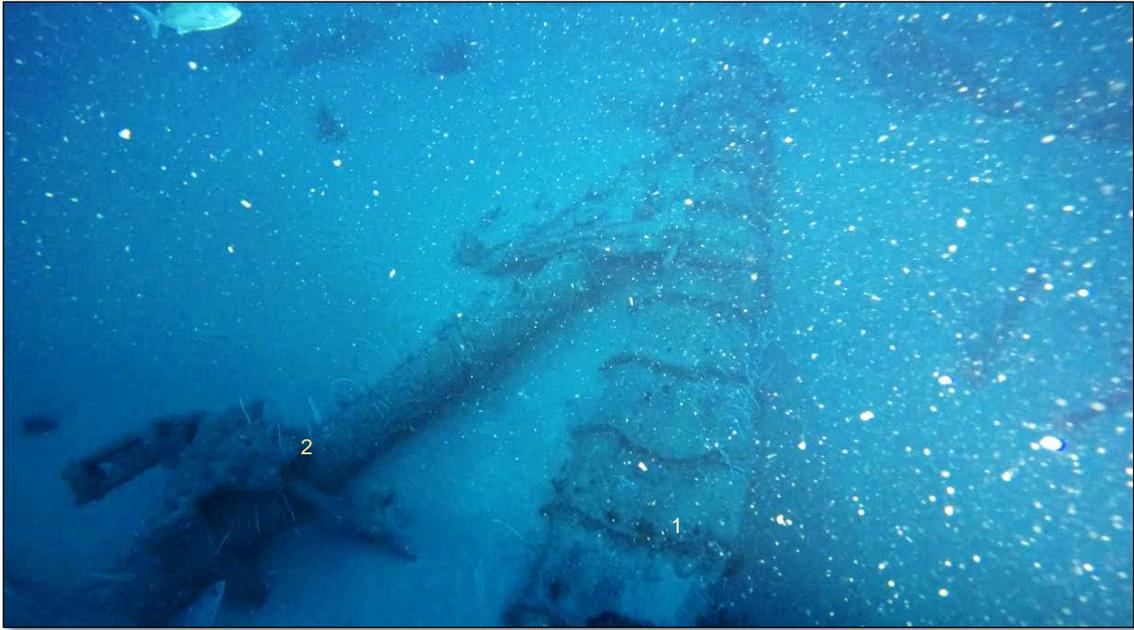
**Figure 66: Possible interior section of bent hull or shaft tunnel plating (1) and derrick crane mast (2) in aft section of wreck facing west (Image: After AUS ROV)**

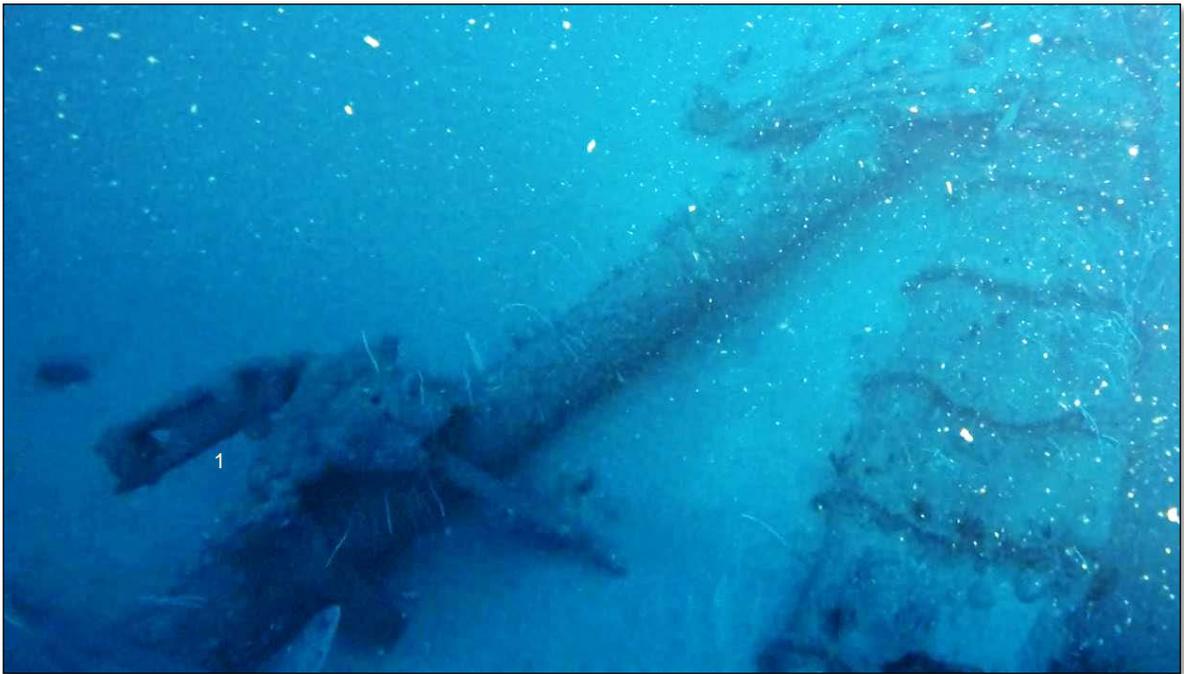
**Figure 67: Closeup of possible derrick crane mast in aft section of wreck, showing rigging attachments for controlling the crane derrick (Image: After AUS ROV 2019)**

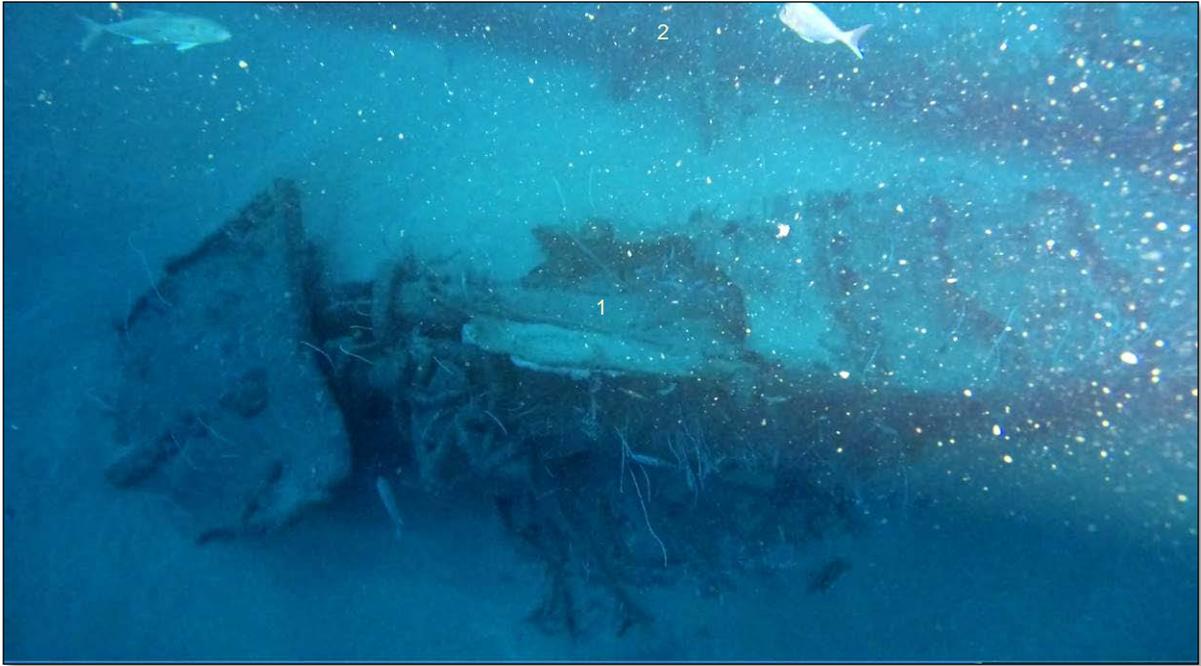
Figure 68: Possible mast step of derrick crane, or hull plate and shaft tunnel section, with derrick crane behind (Image: After AUS ROV 2019)

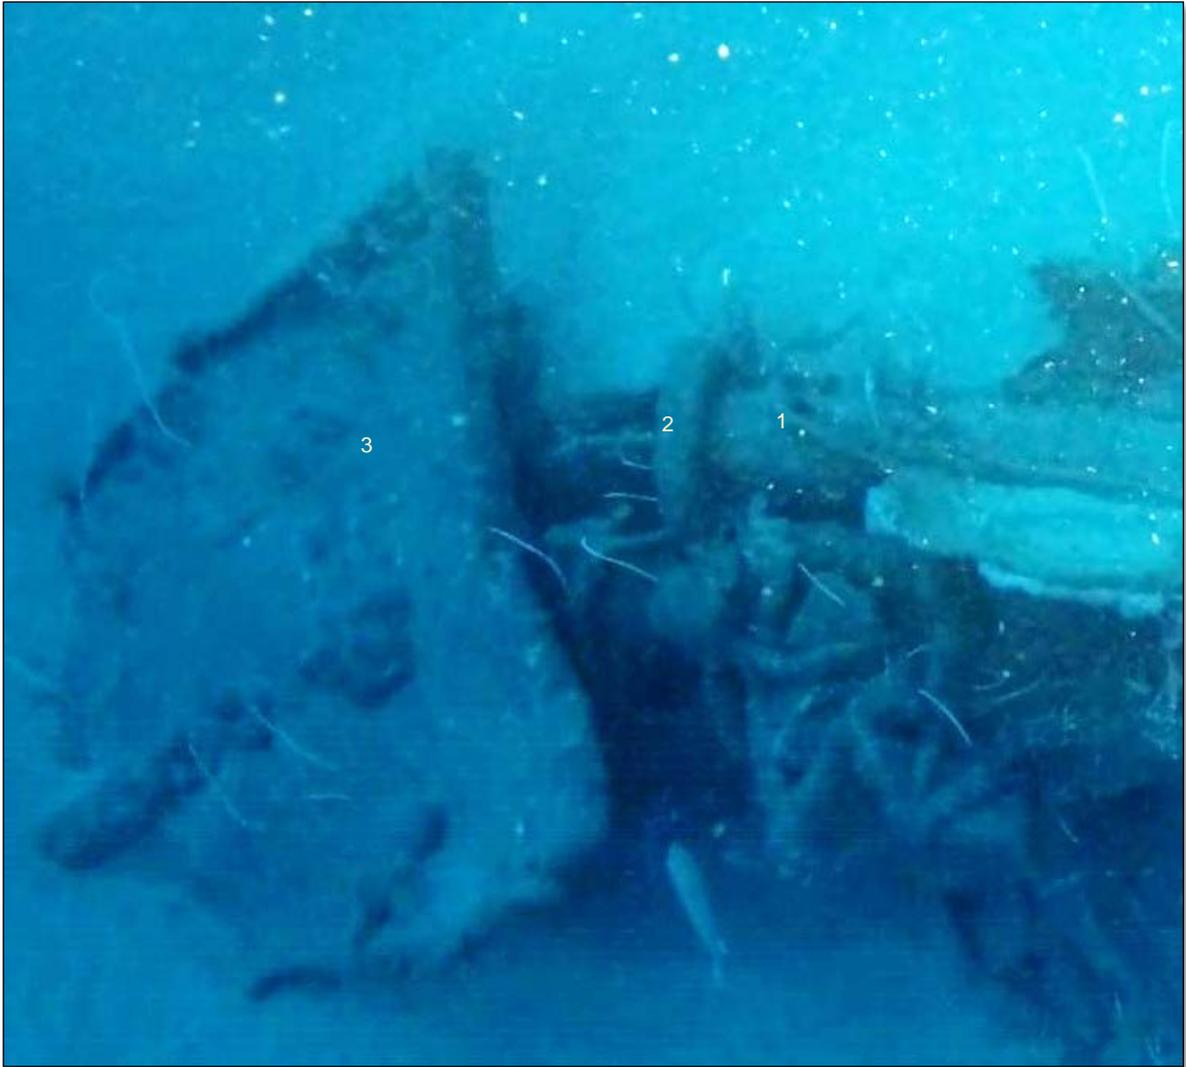
Figure 69: Closeup of possible mast step of derrick crane mast; or stern propulsion drive shaft tunnel, drive shaft (1), stern-gland (2) and hull plating (3) (Image: After AUS ROV 2019)

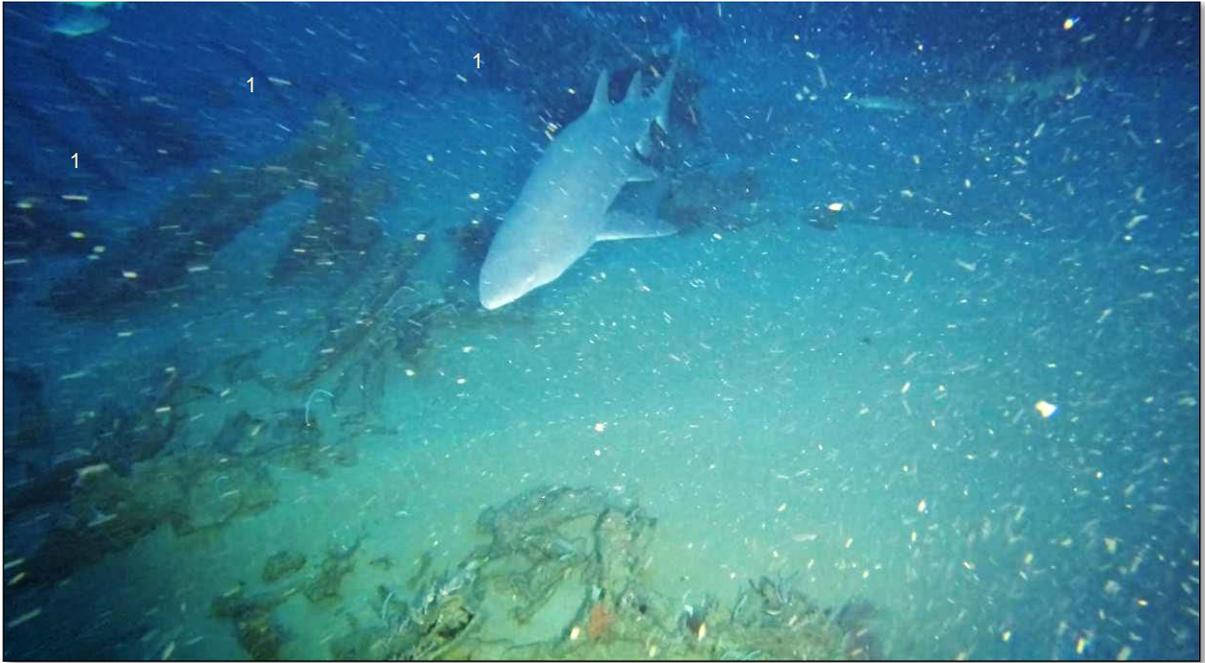
Figure 71: Stern section view from west athwart the site. Note upright frames (1) running athwart the wreck orientation and the grey nurse shark (Image: After AUS ROV 2019)

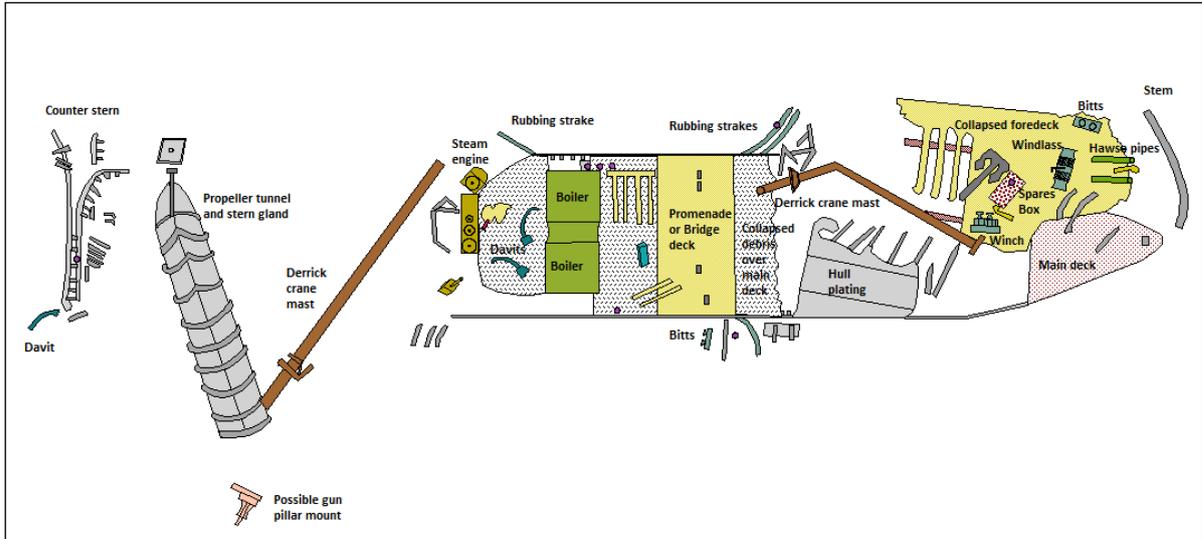
Figure 73 shows a sketch map of the shipwreck based on the ROV inspection videos. When compared to the 3D photogrammetric model generated by Daniel Adams of the HIVE Centre, Curtin University (Figure 74), which was provided as this report was being finalised, the detached nature and orientation of the stern section is even more pronounced than originally thought, lying approximately 120 degrees to its original location within the ship. Further works are planned with the HIVE Centre to compare and check the accuracy of the model with the multibeam sonar data, but this model further demonstrates the great utility of using photogrammetry to map and interpret these deep-water sites.

Figure 73: Sketch plan of *Wollongbar* (II) based on ROV footage. Note portholes shown as purple circles scattered throughout the wreck (Image: Brad Duncan, Heritage NSW 2020).

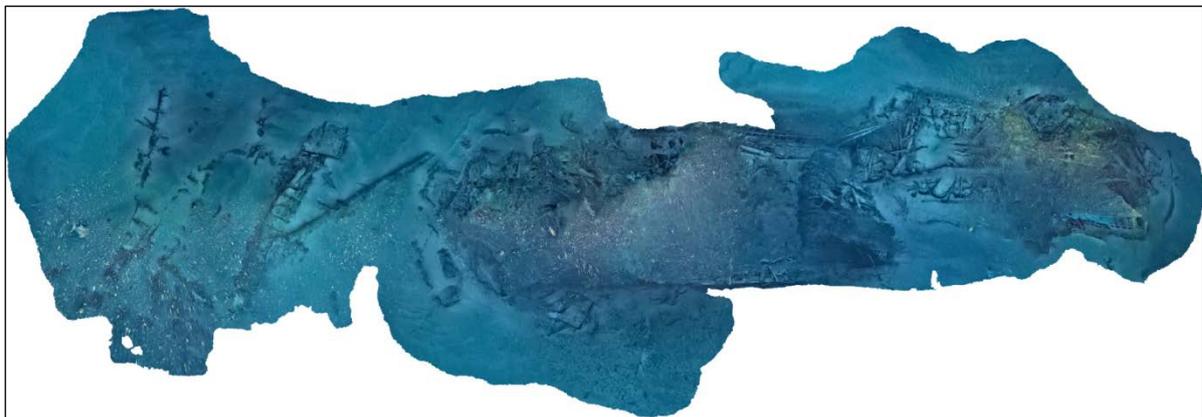
Figure 74: Birds eye view of the 3D photogrammetric model showing the layout of the site (Image: Daniel Adams, HIVE Centre, Curtin University, WA)

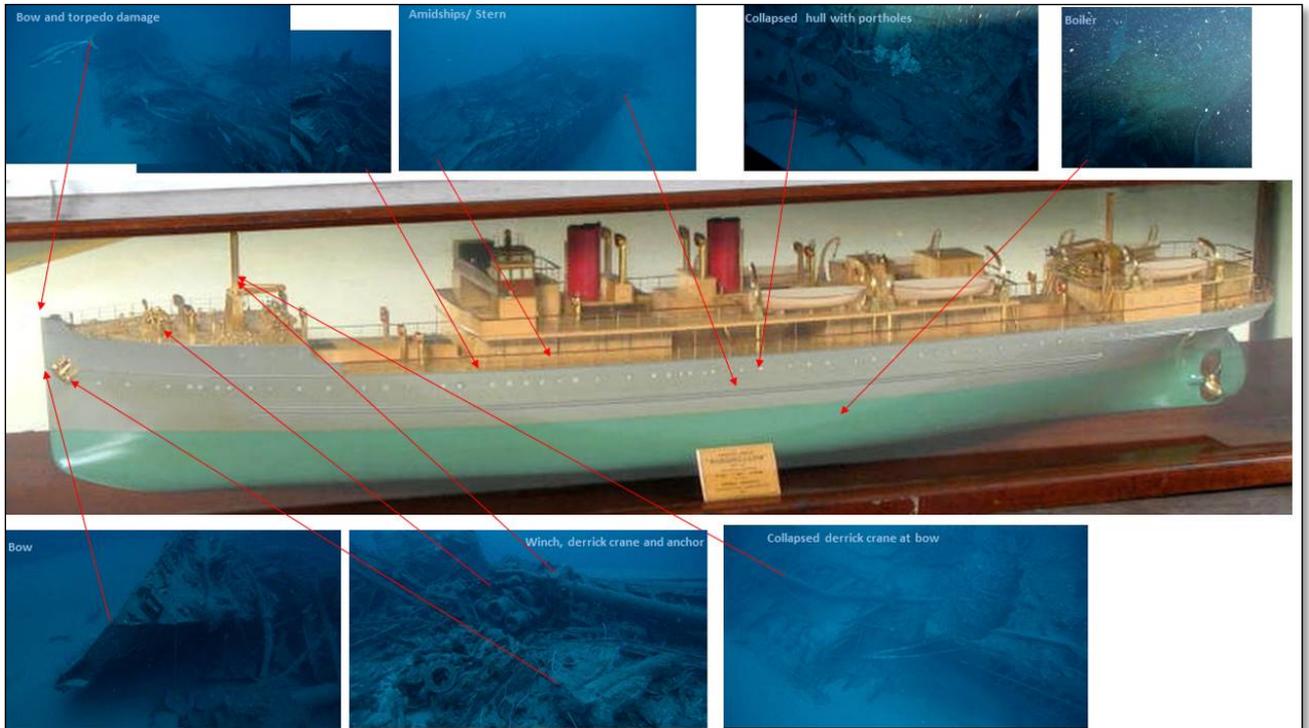
In conclusion, from analysis of the ROV footage and the comparison with the Mid North Coast Maritime Museum Half Model, there is compelling evidence to suggest that the wreckage inspected off Crescent Head is indeed the wreck of the *Wollongbar* (II) (Figure 86 and Figure 87).

Figure 86: Corresponding features between the wreck site and the MAAS *Wollongbar* (II) half ship model on the port side (Image: Brad Duncan, Heritage NSW)

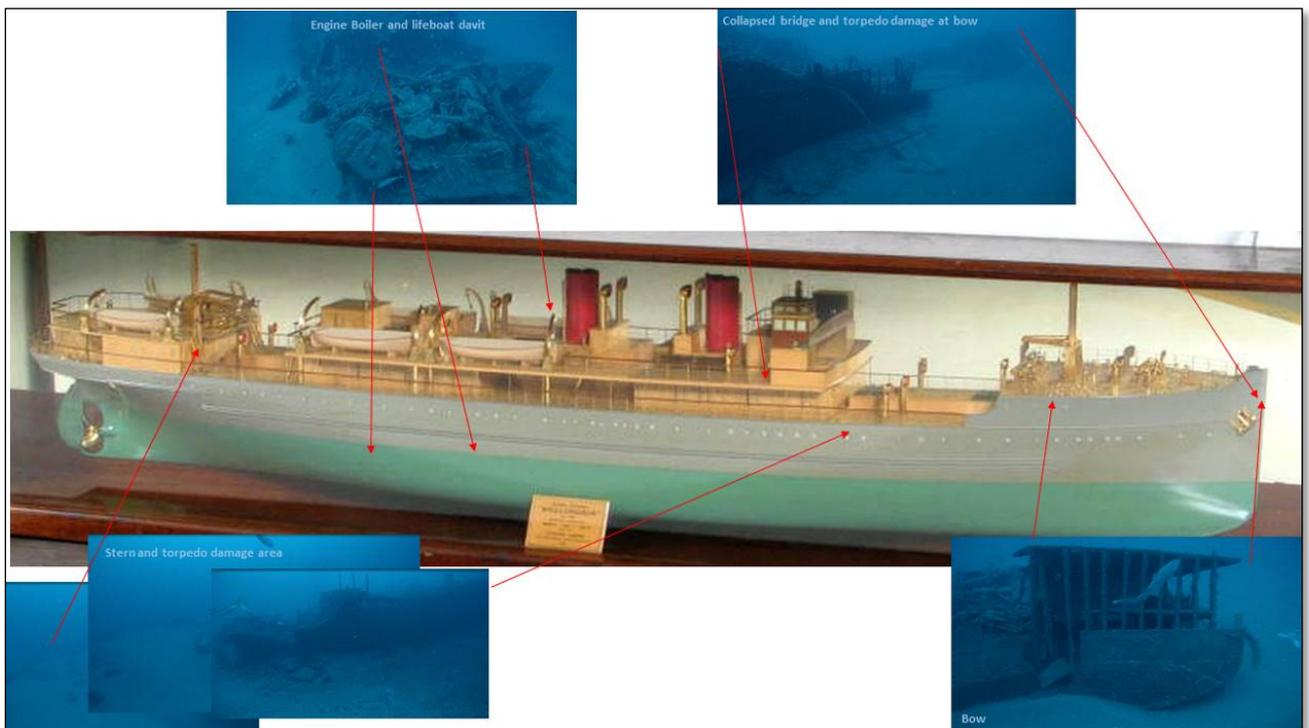
Figure 87: Corresponding features between the wreck site and the MAAS *Wollongbar* (II) half ship model on the starboard side (Image: Brad Duncan, Heritage NSW)

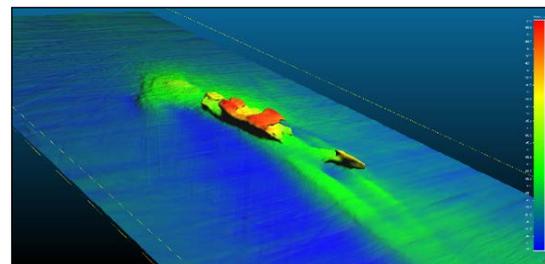
*Multibeam survey of the Wollongbar* (II) (Image: AUS ROV)

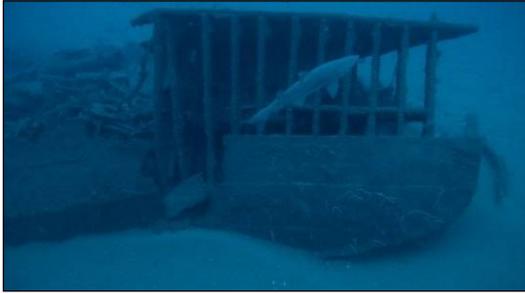
The wreck shows signs of extensive torpedo damage and has been blown up just aft of the bow and forward of the bridge, and at the stern just aft of the steam engine (behind the aft funnel). The stern section appears to be lying in pieces at a 90-degree angle to the rest of the vessel. The upper decks have been blown upwards as a result of the blast and have then collapsed back into the hull of the vessel. The wreck is in very poor

condition, with only sections of the midships and bow remaining partially intact. It is home to a previously unknown

*Bow of Wollongbar (II) wreck (Image: AUS ROV)*

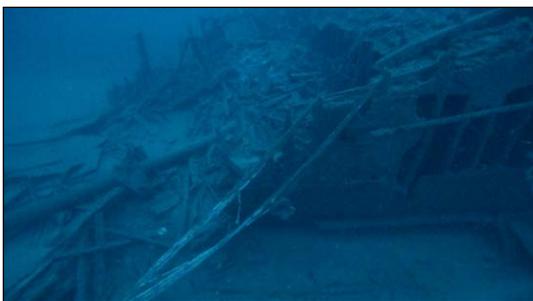
*Torpedoed area just forward of the bridge (Image: AUS ROV)*

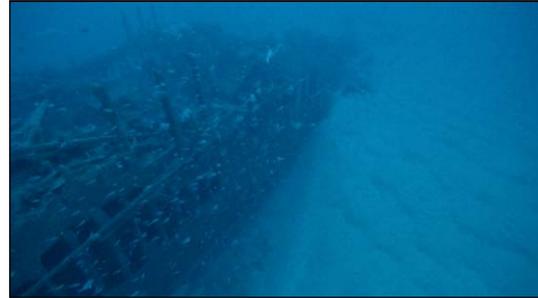
*View of aft torpedoed area at stern (Image: AUS ROV)*

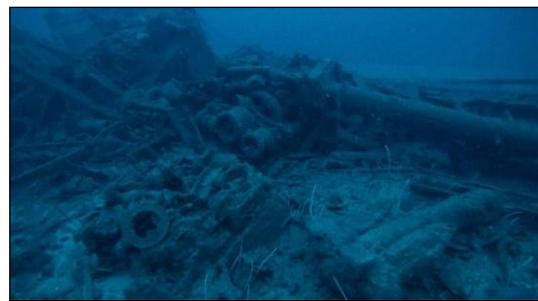
*Winch, anchor and fallen derrick crane (Image: AUS ROV)*

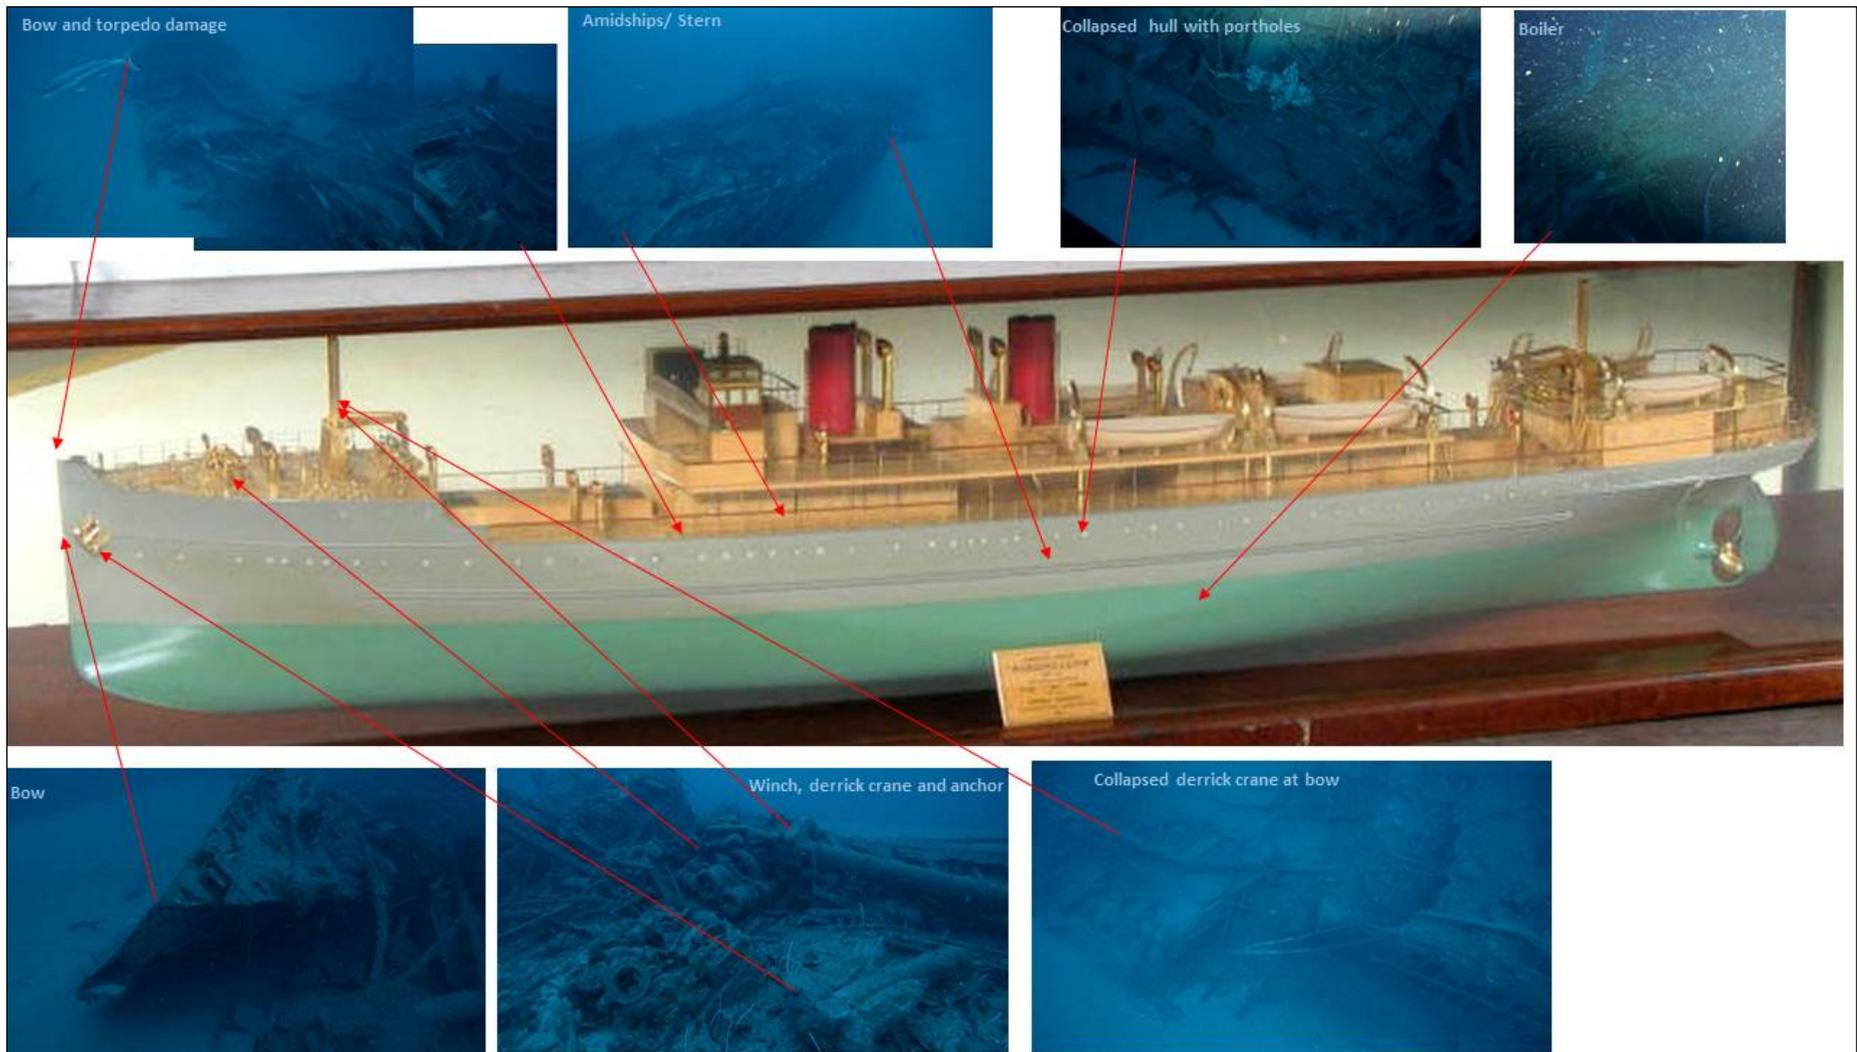
**Schematic of ROV fieldwork results against ships model of the *Wollongbar* (II)**
